Istituto di Geografia Umana – Stazione Valchiavenna

*Deterioration processes and definition  
of different risk typologies*

Alpter Project - EU Programme Interreg IIIB Alpine Space  
*Terraced landscapes of the alpine arc*

Second Transnational Workshop  
3-4 November 2005, Sondrio

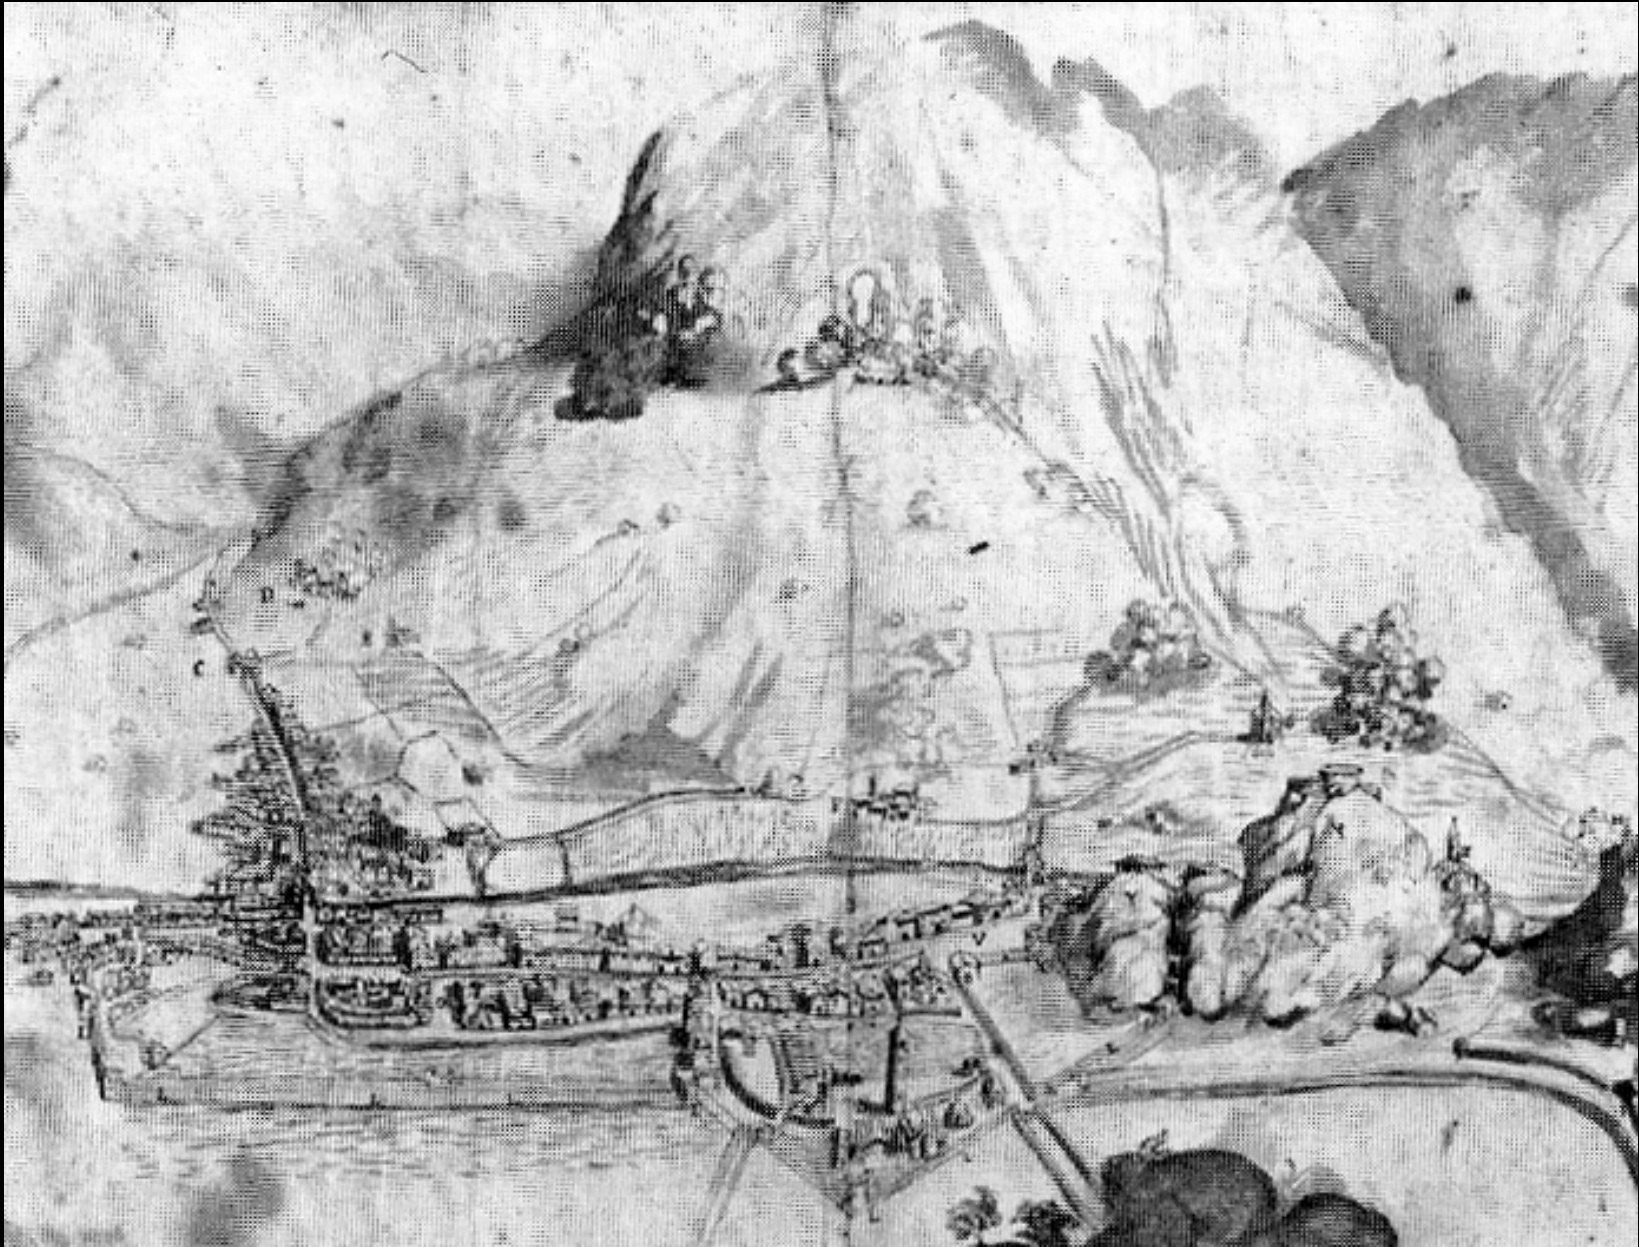
*In the most inaccessible,  
unfruitful and marginal areas  
the origin of the terracings is  
more recent*

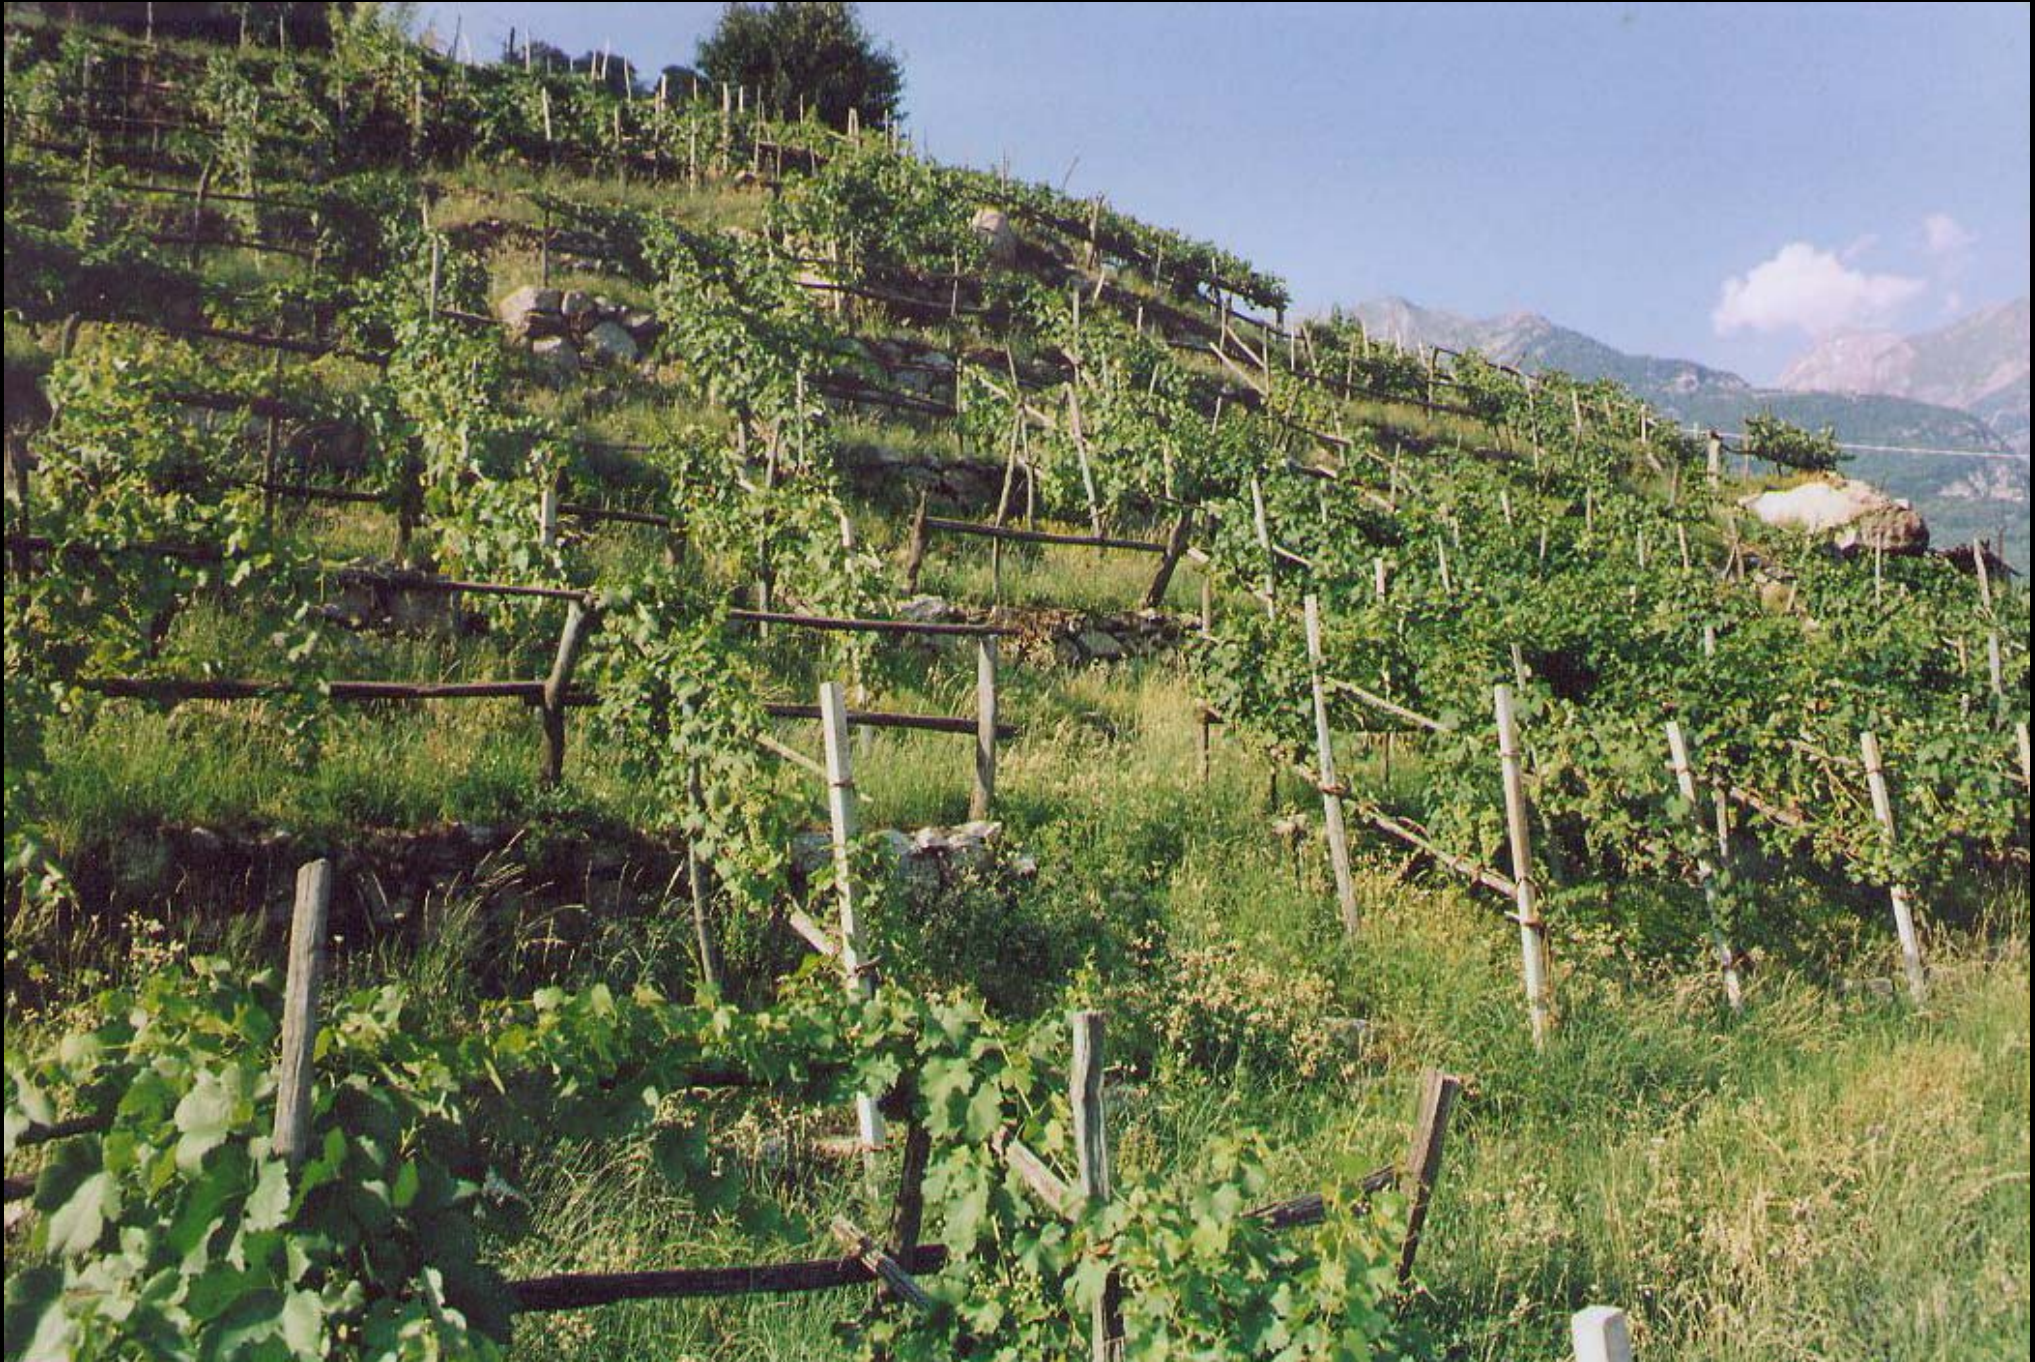
**In some sectors, the solidity of walls is guaranteed by the permanence of cultivations (of vines, most of all)**

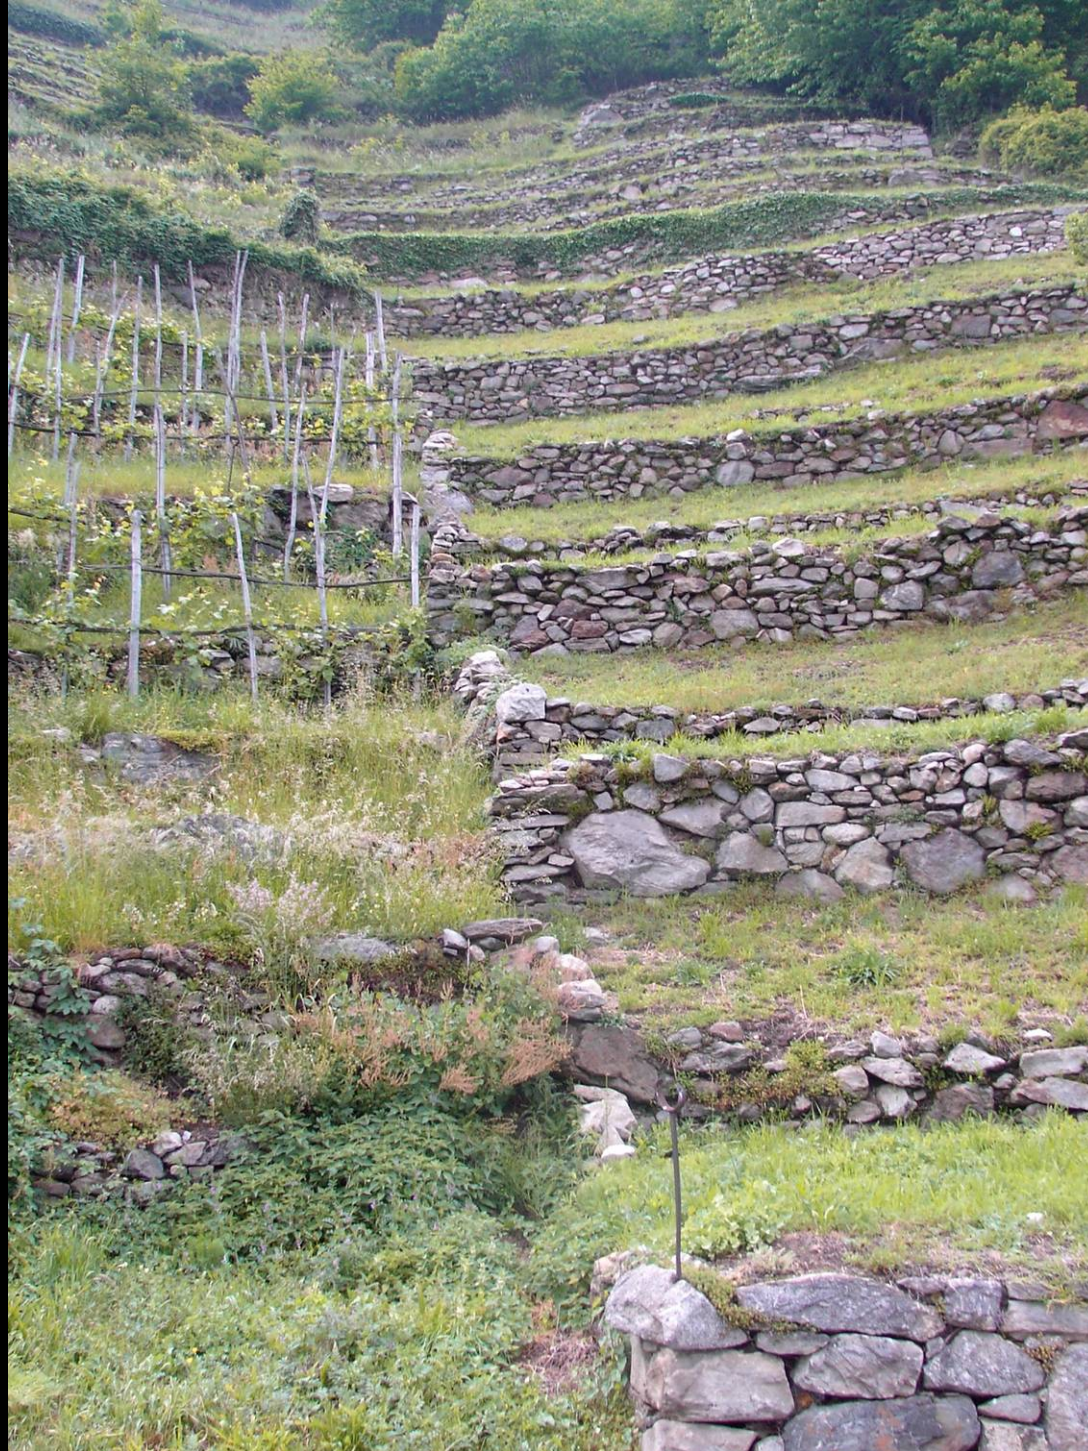
*... and, after the abandonment, by the quality of the building system*

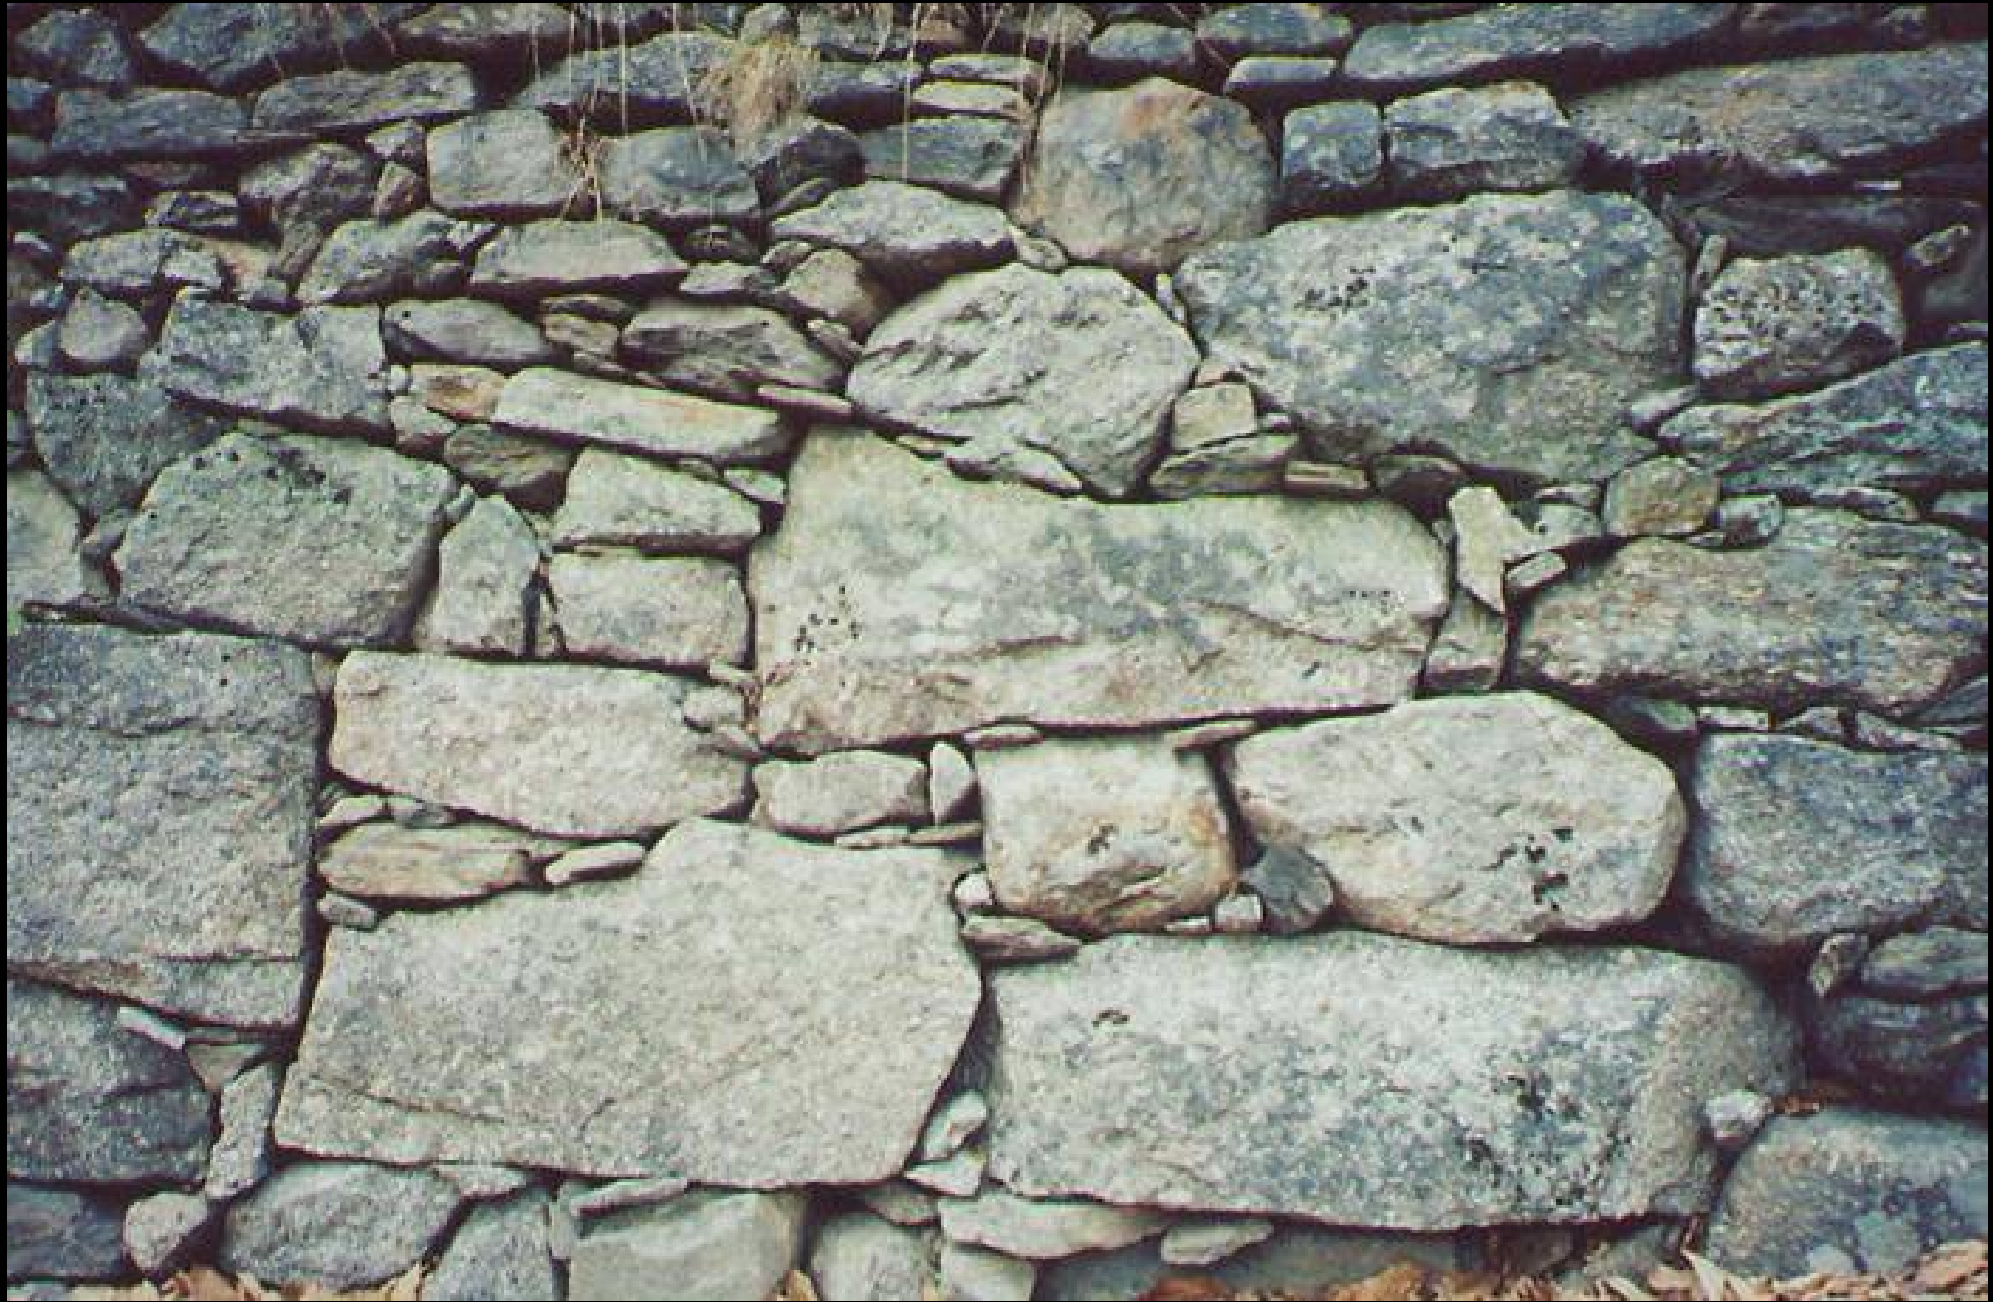
*Building quality: shape and size of the blocks;  
disposition in the wall*

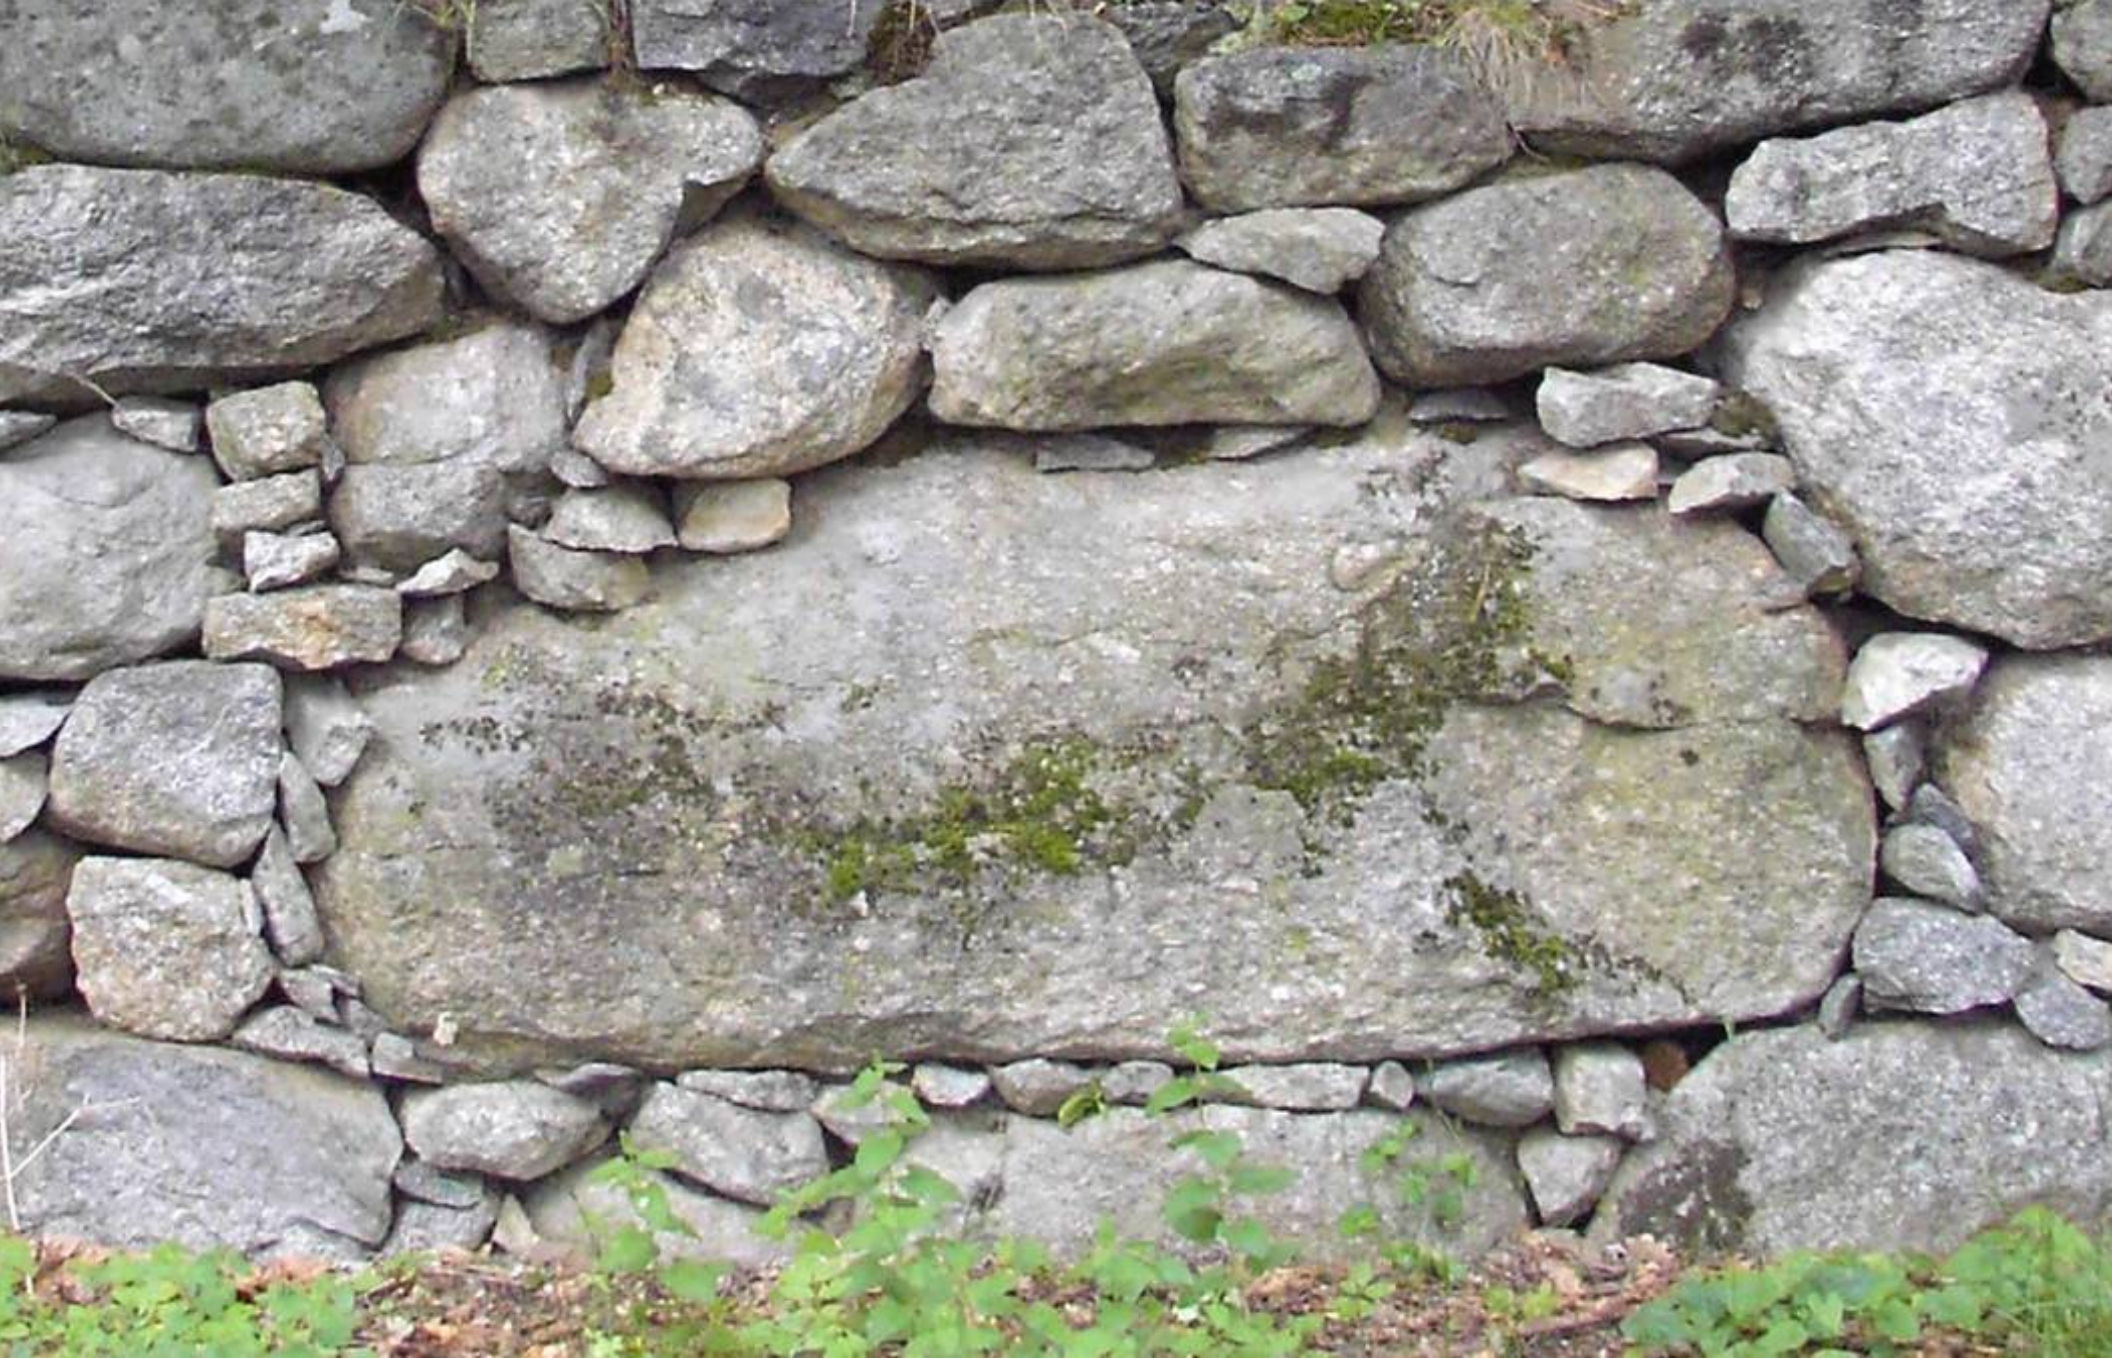
**Geometric embeddings with lithic fragments**

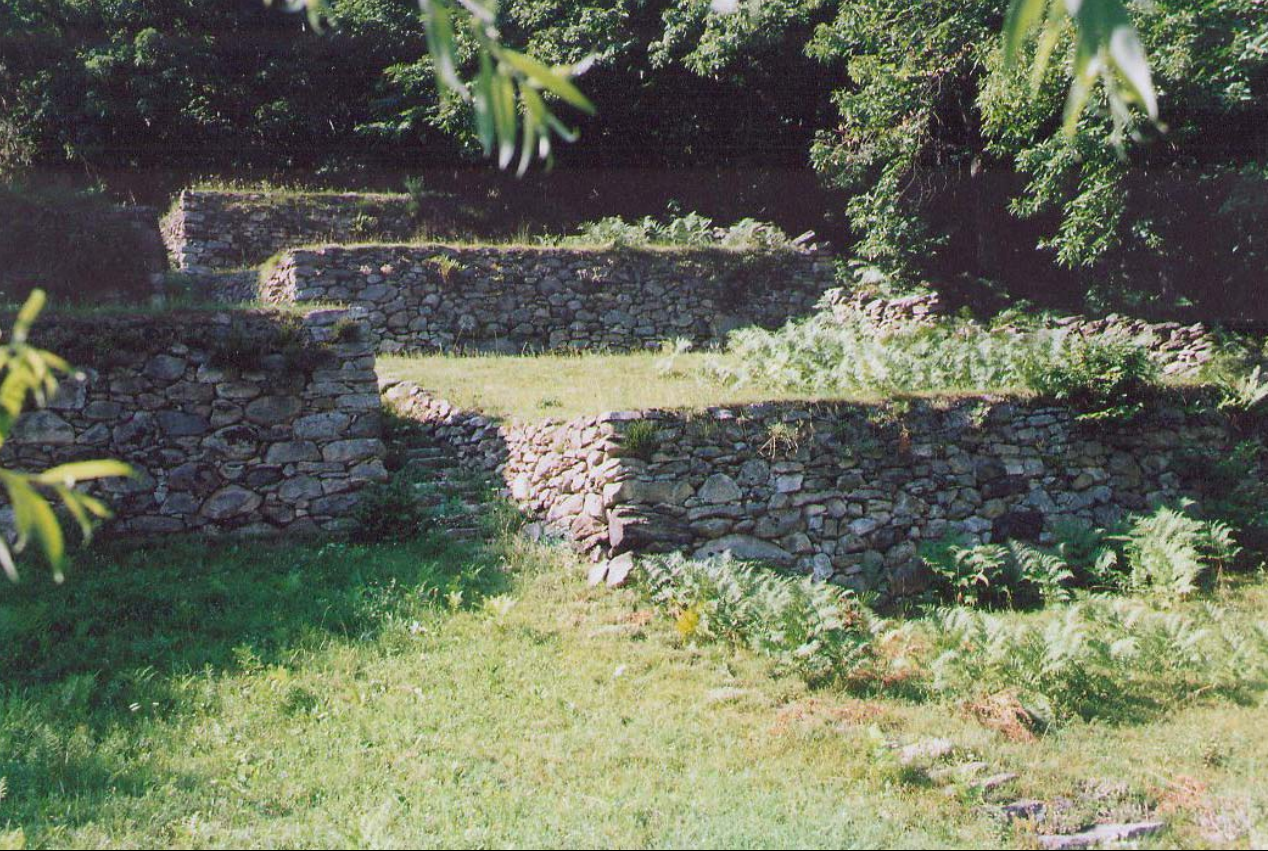
*An examples of huge dimension terracing  
(the walls are 3,5 metres high) with a good  
building quality technique*

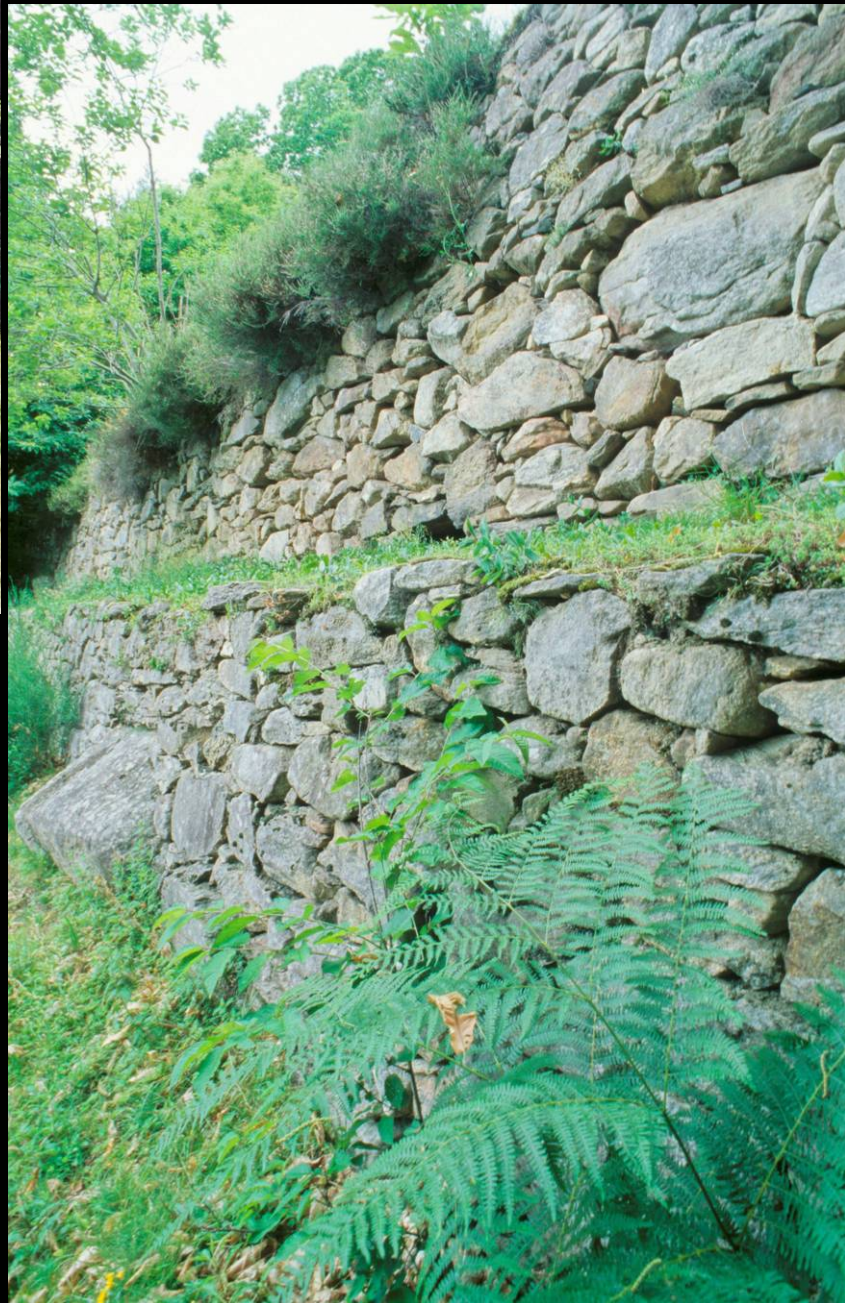
*Micro-terracing of good building quality for the cultivation of chestnuts on high slopes*

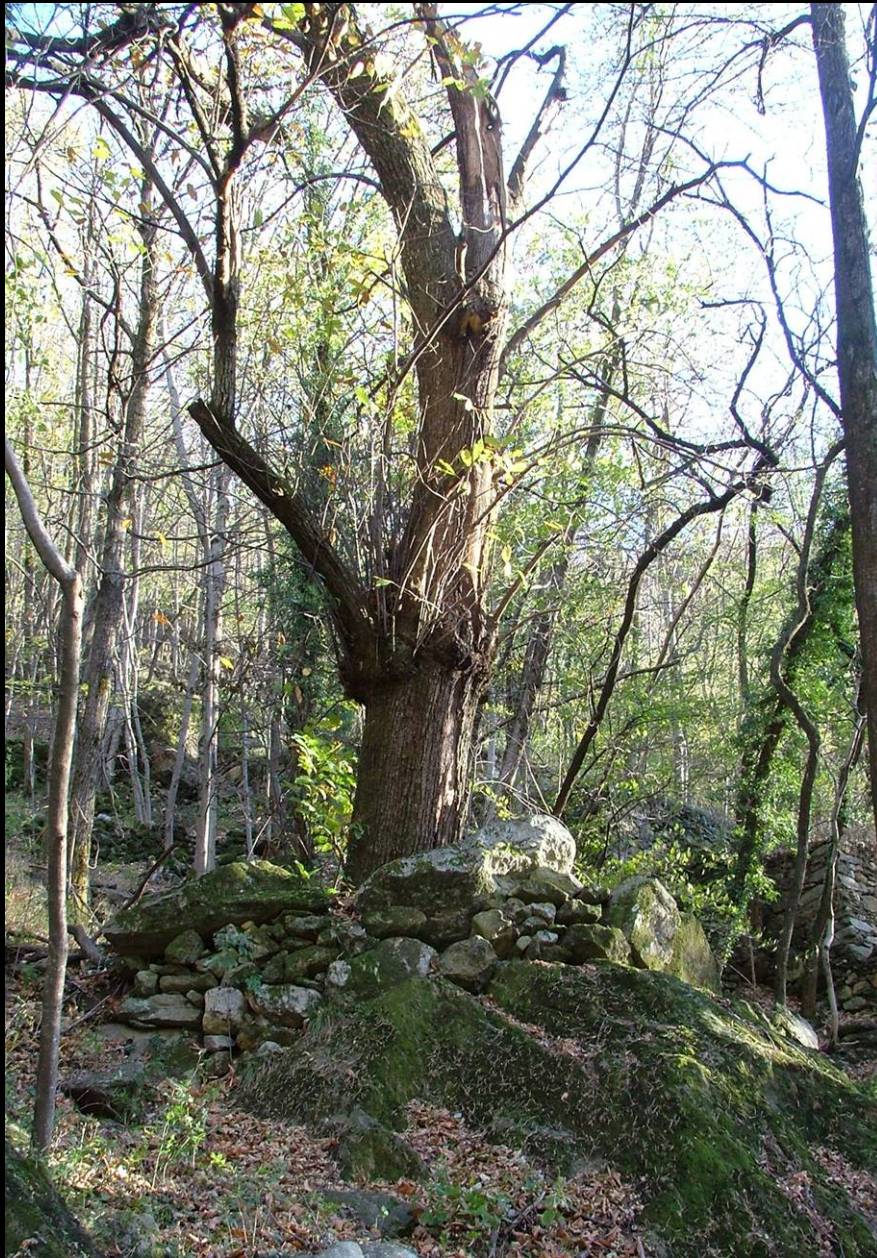
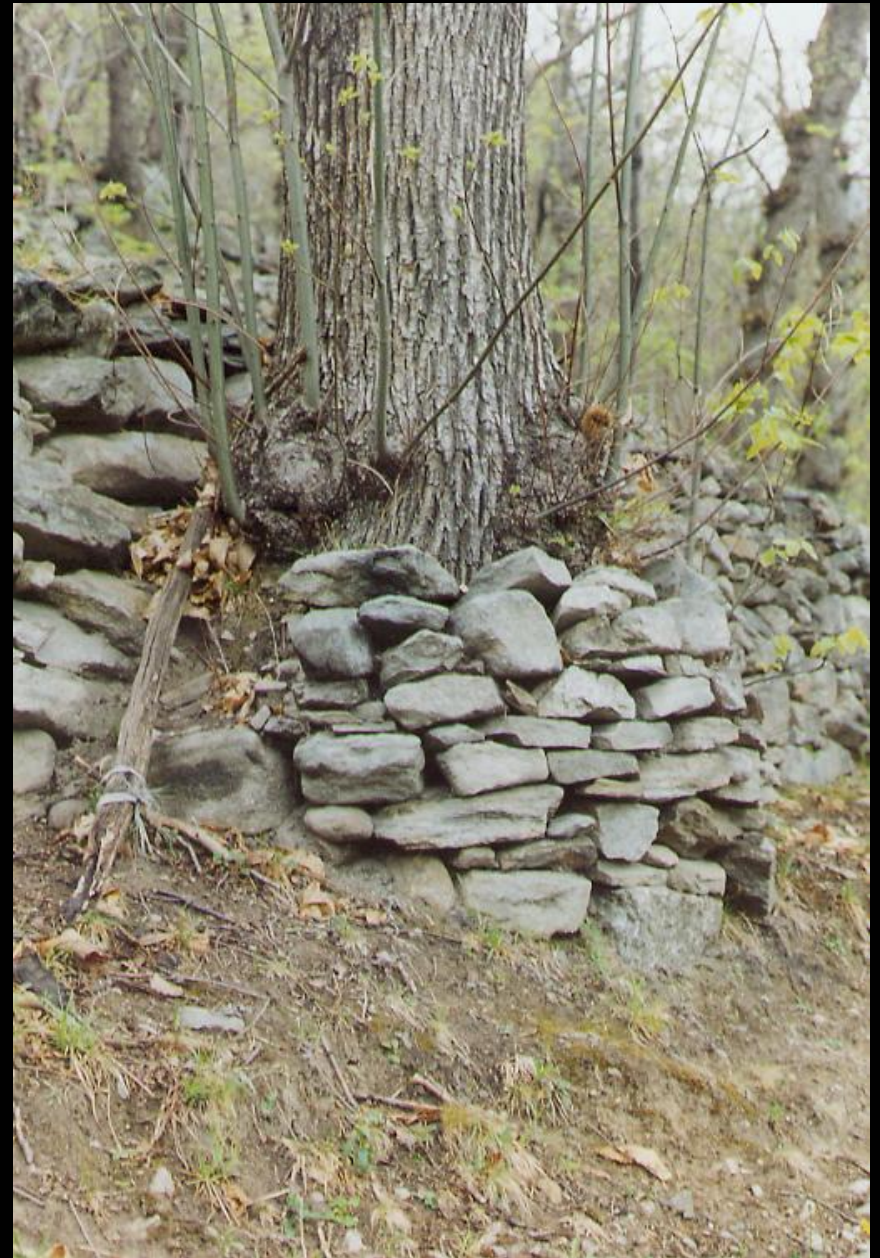
*Hanging micro-terracing of good building quality*

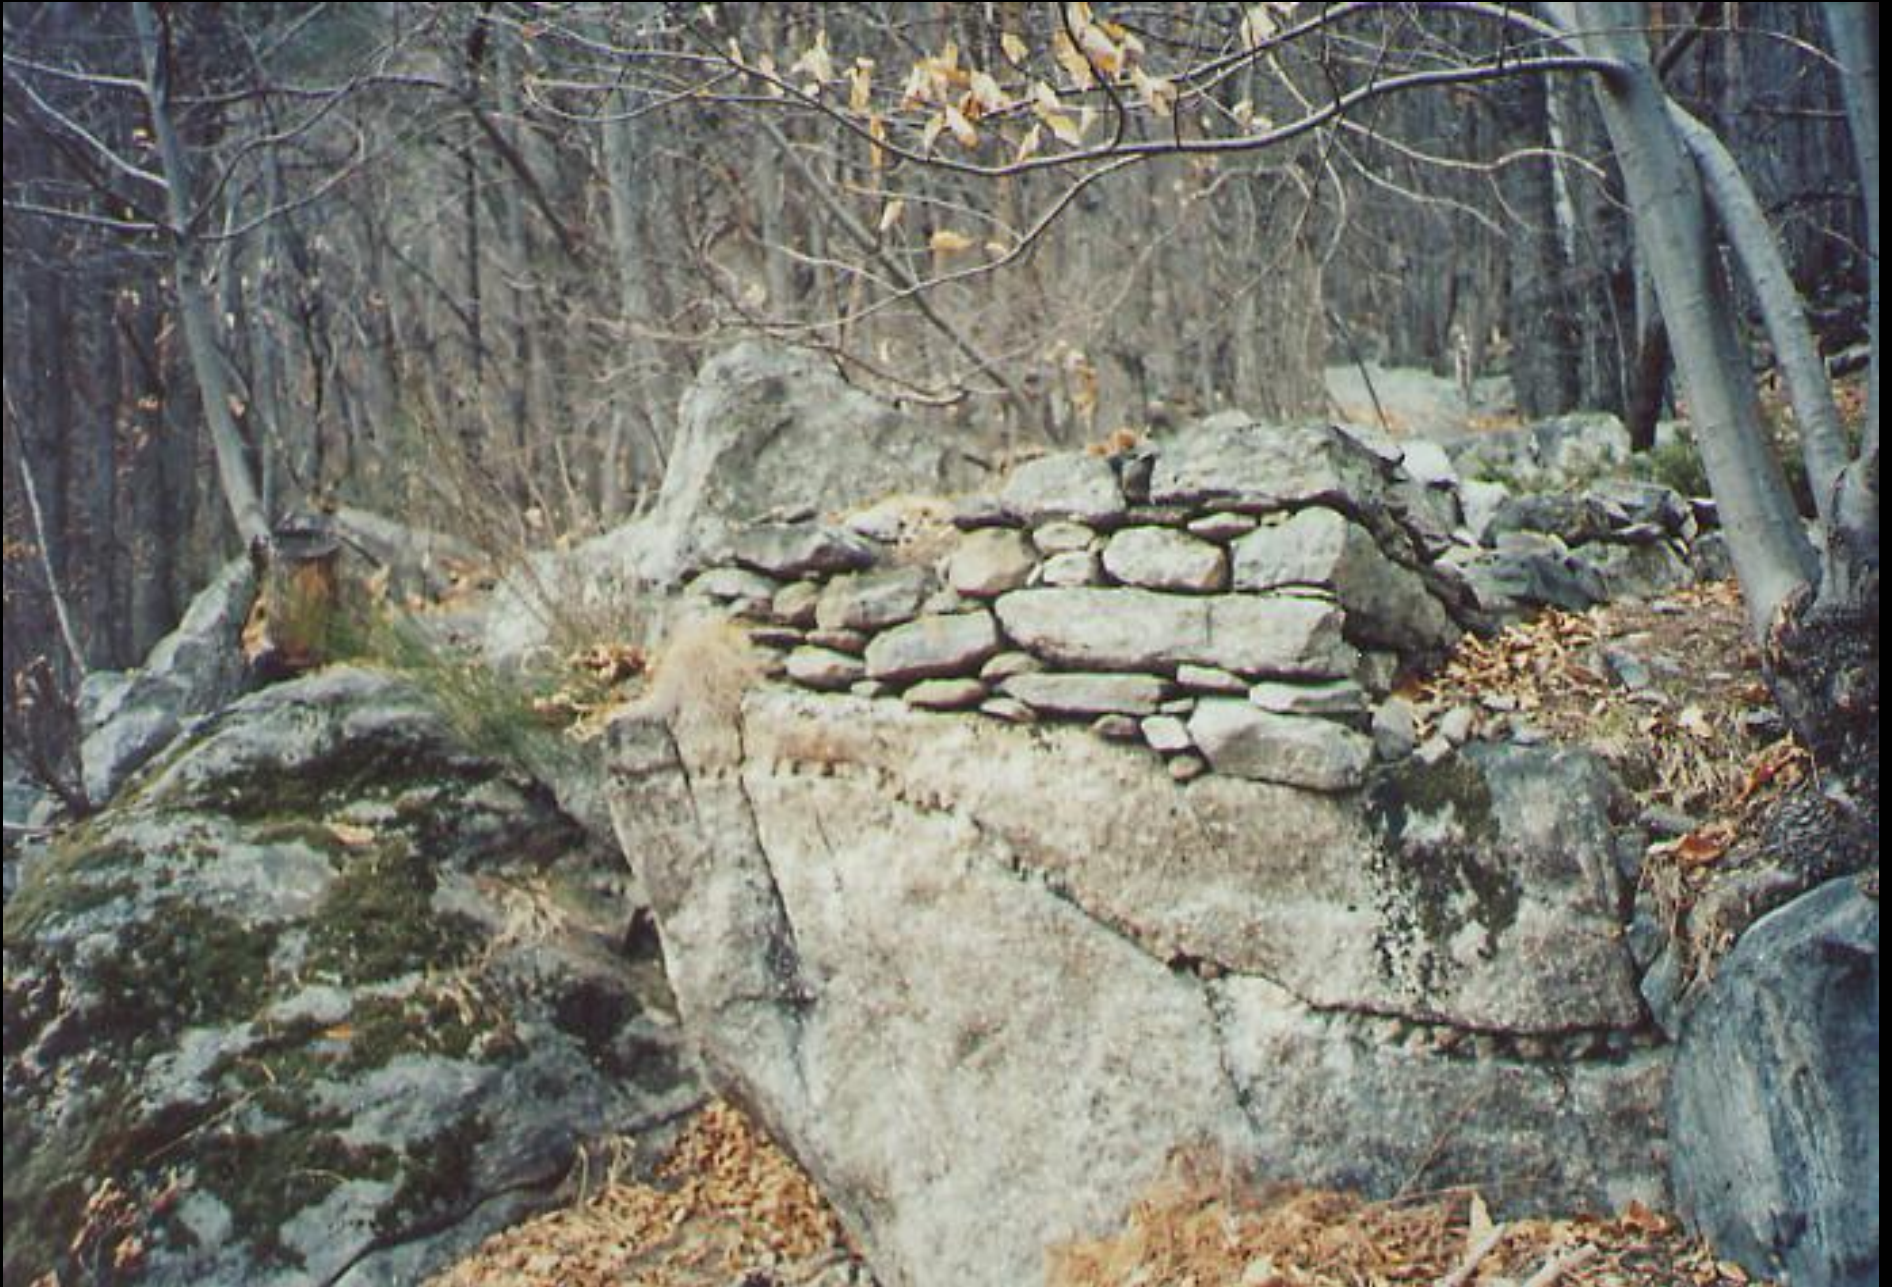
*Micro-terracing of good building quality for the chestnuts cultivation*

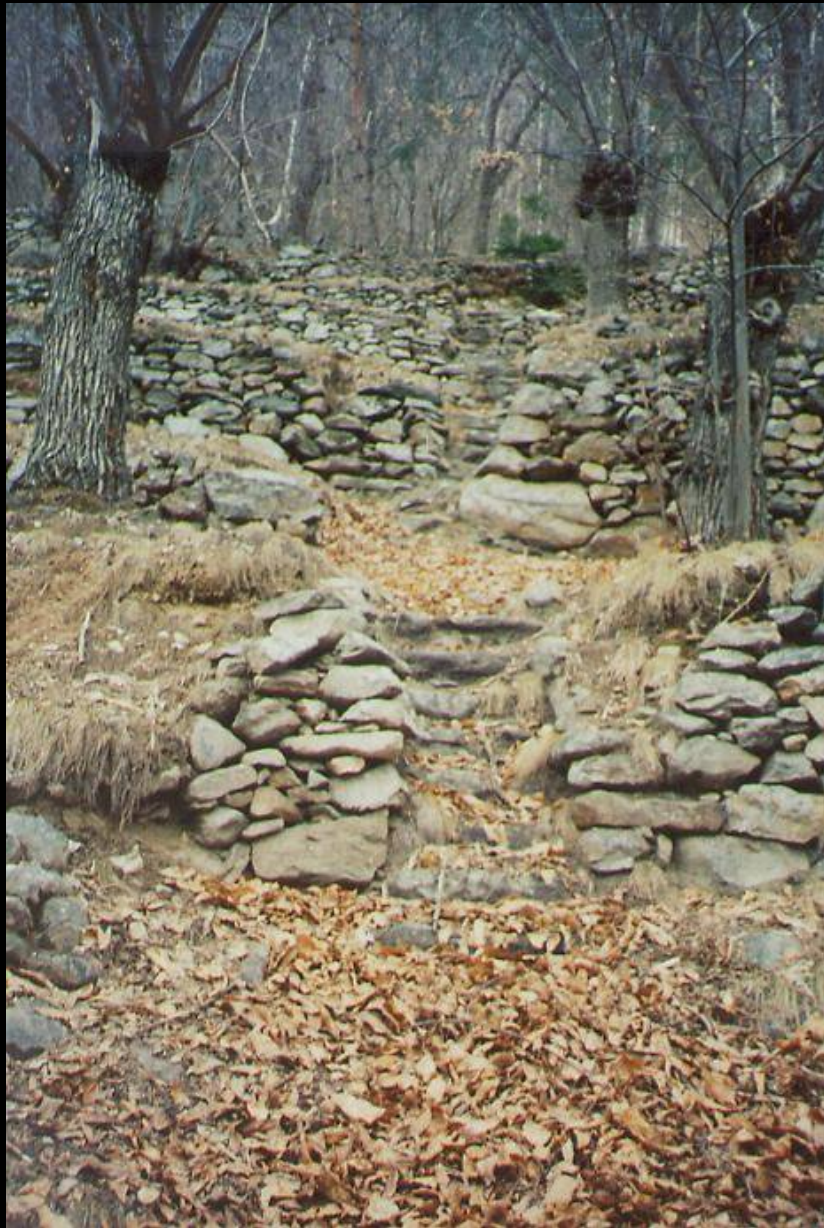
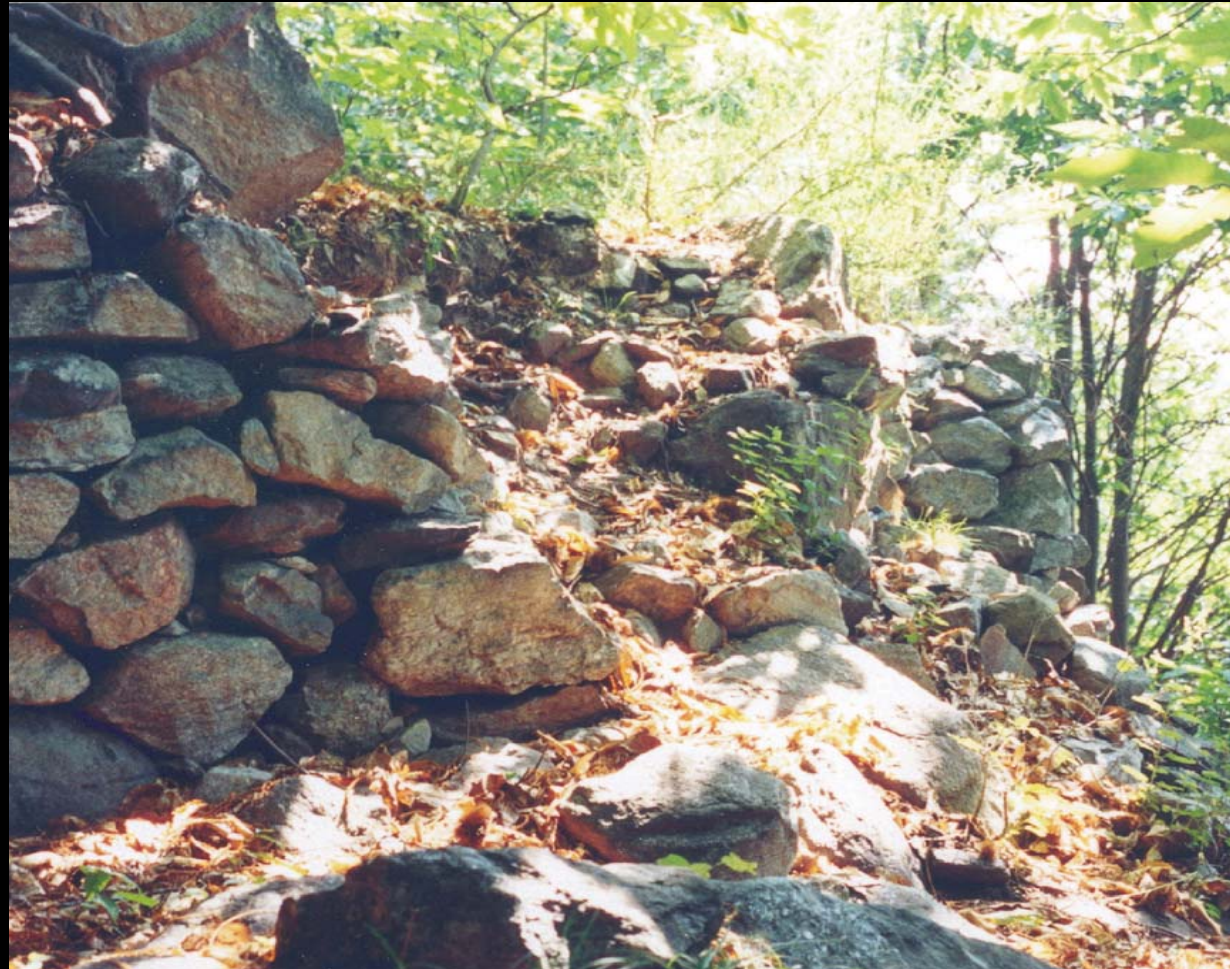
# Mediocre building quality

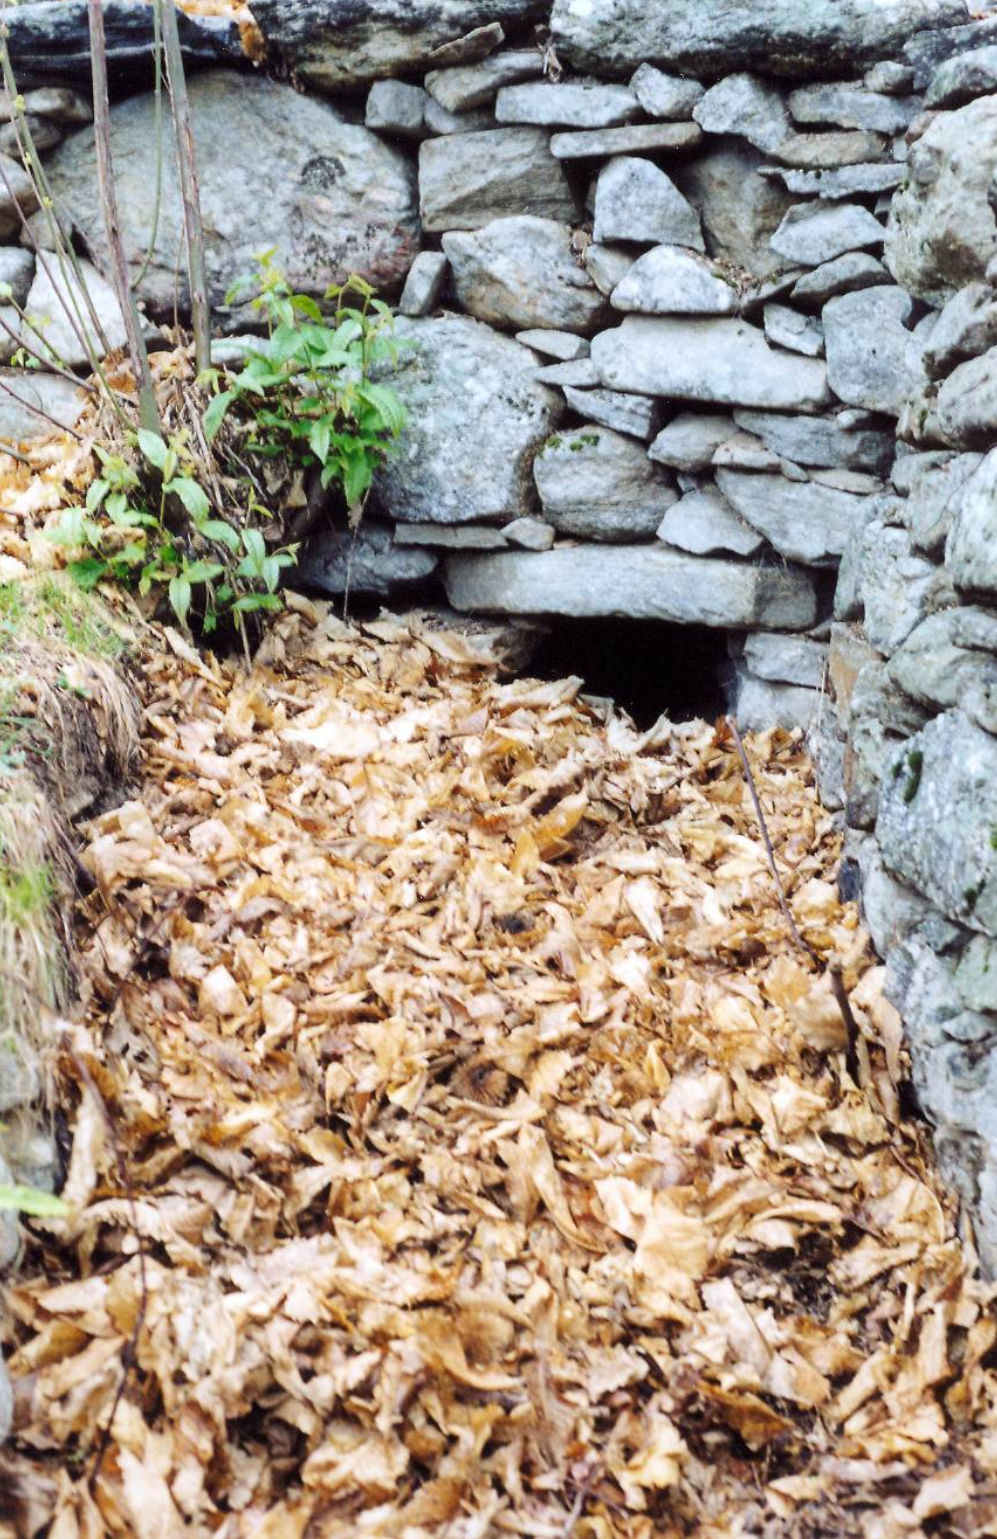
*Abandonment: occlusion of the superficial drainage network*
