Istituto di Geografia Umana – Stazione Valchiavenna

*Deterioration processes and definition  
of different risk typologies*

Alpter Project - EU Programme Interreg IIIB Alpine Space  
*Terraced landscapes of the alpine arc*

Second Transnational Workshop  
3-4 November 2005, Sondrio

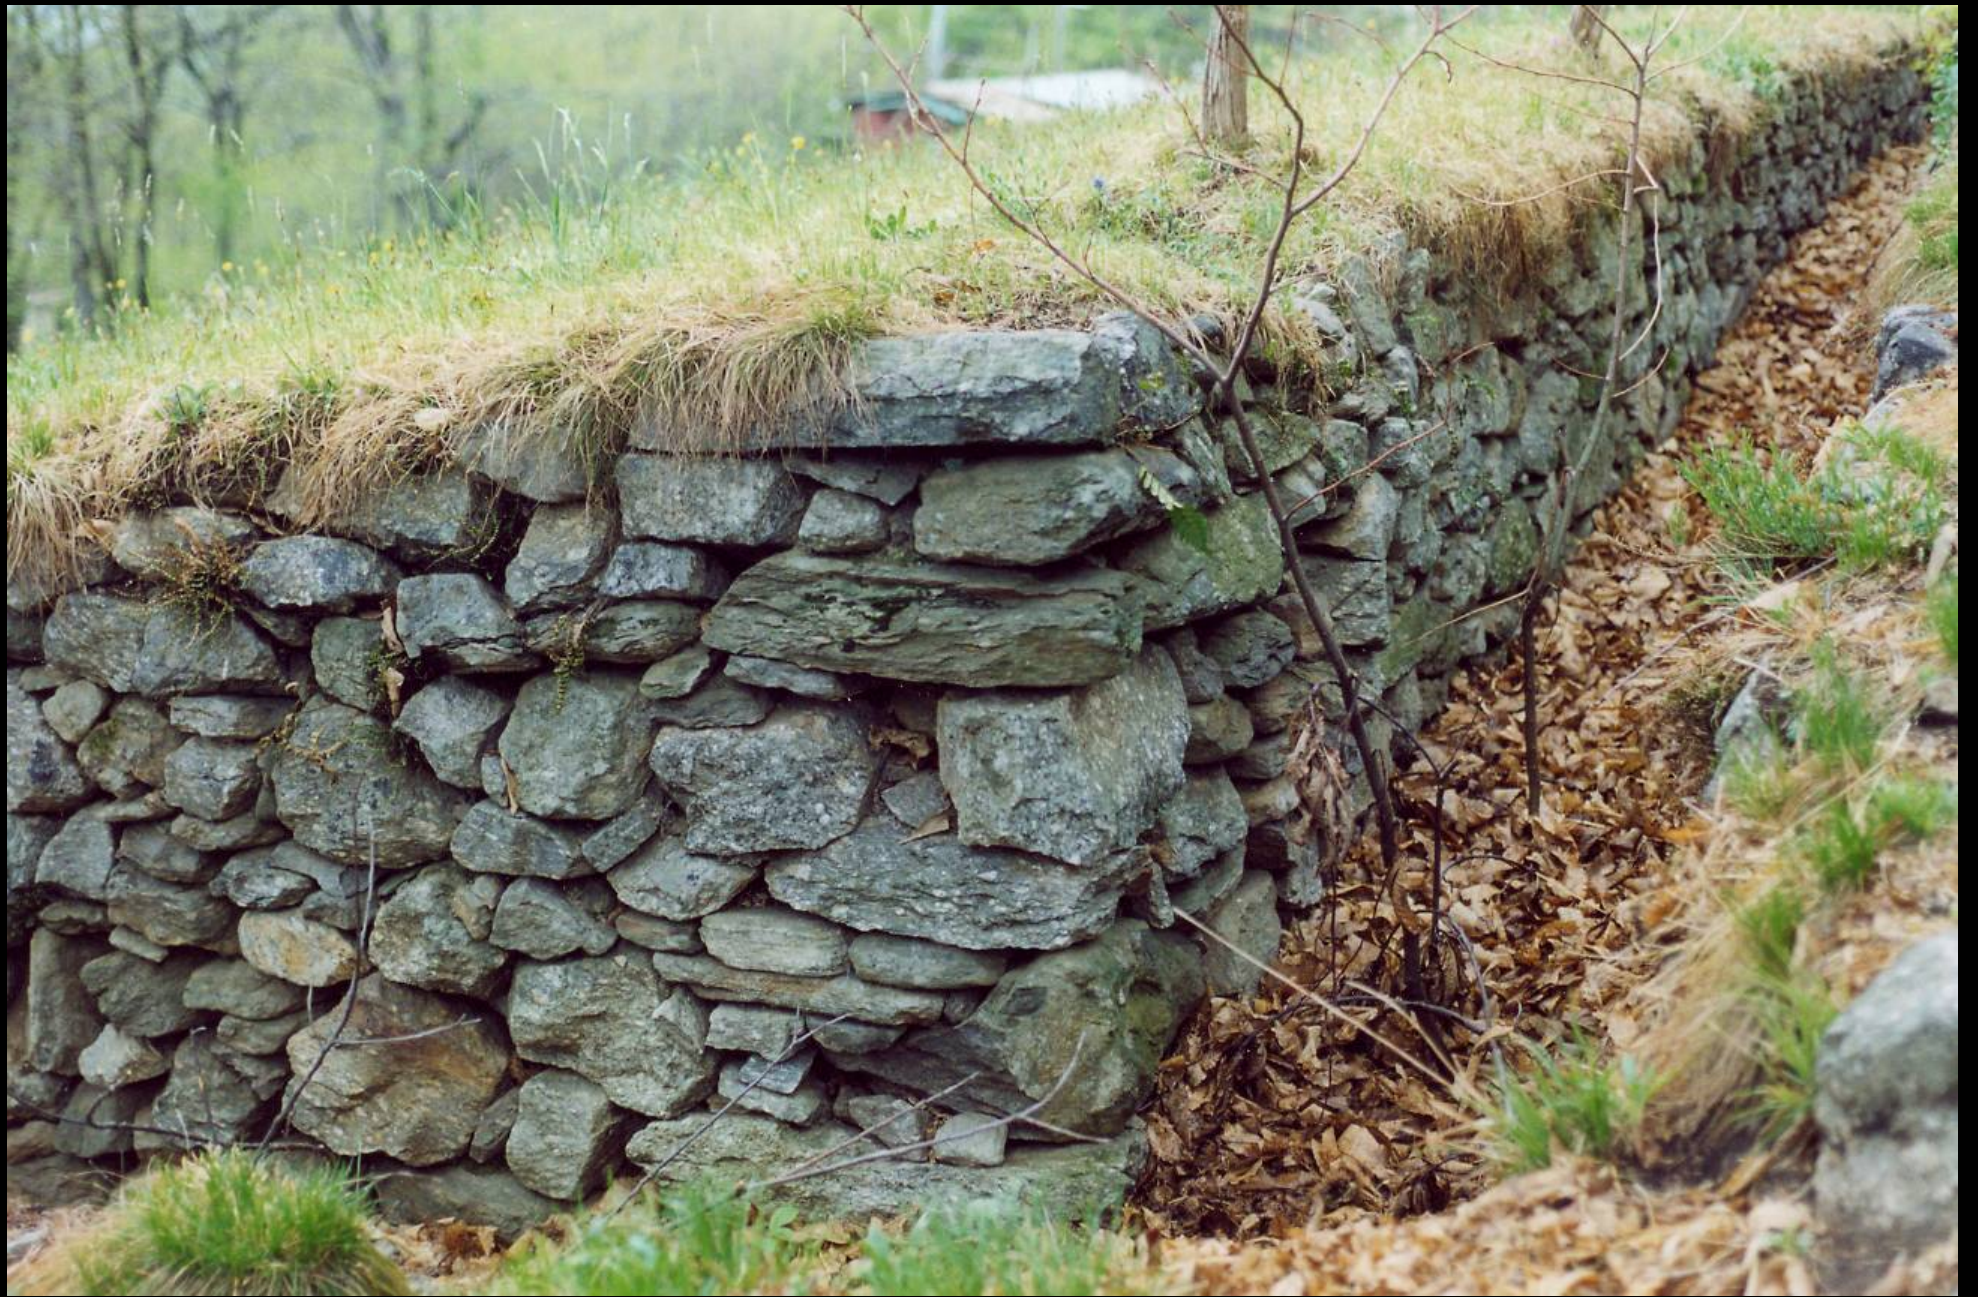
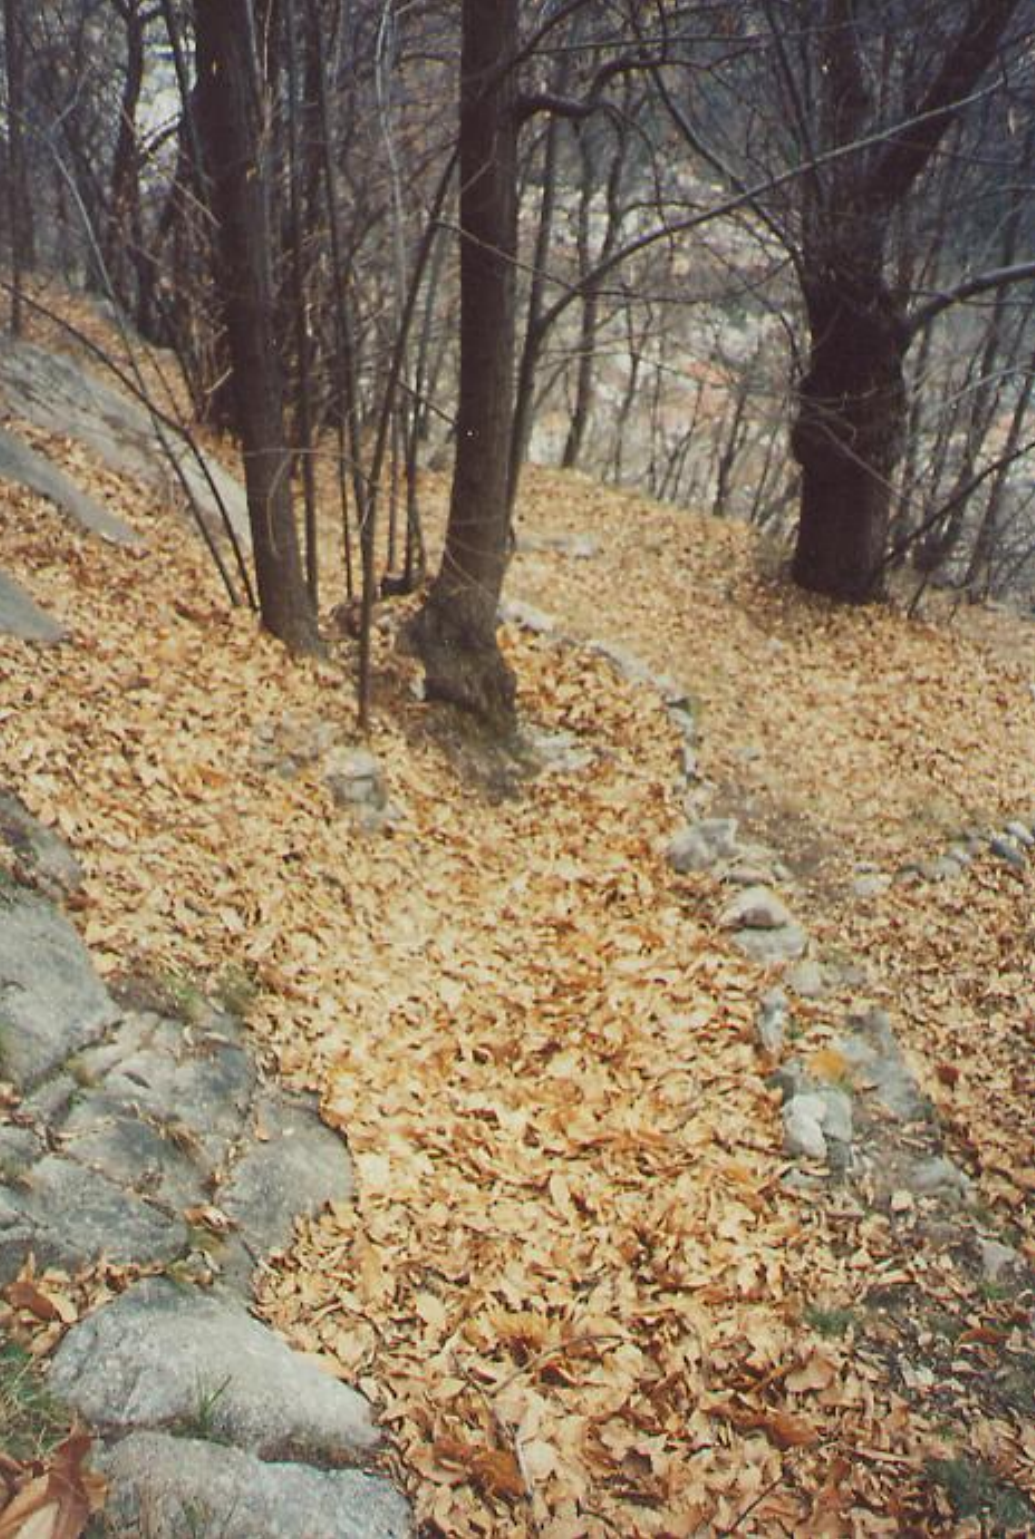
*Abandonment:  
lack of maintenance in the lines  
of communication which, in  
certain cases, constitutes  
segments of the superficial  
drainage network of waters*

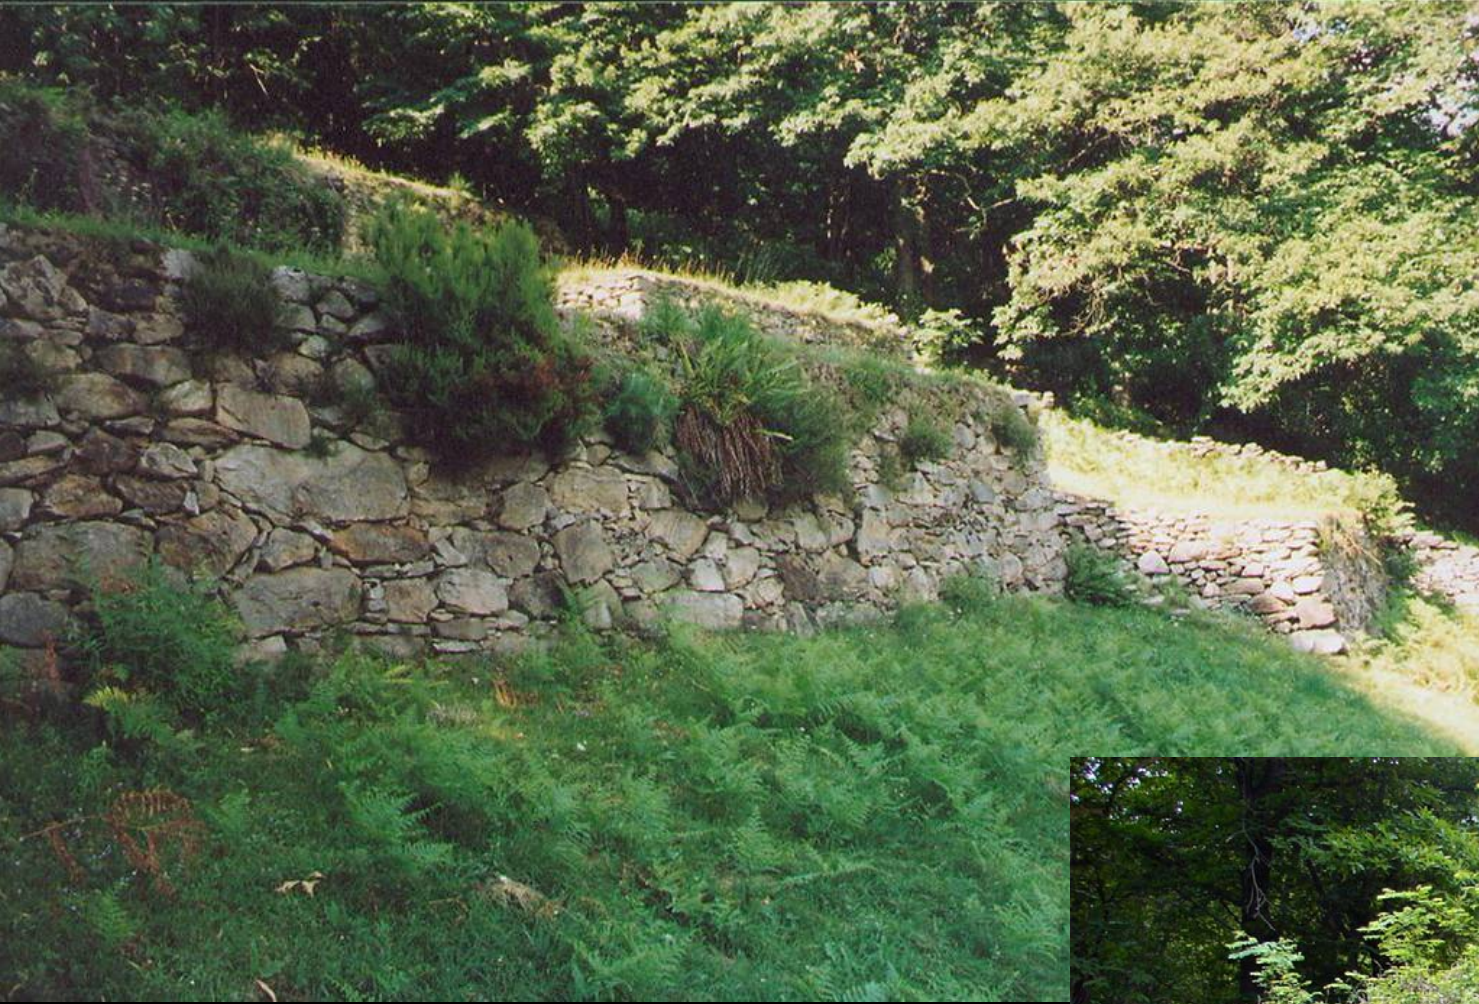
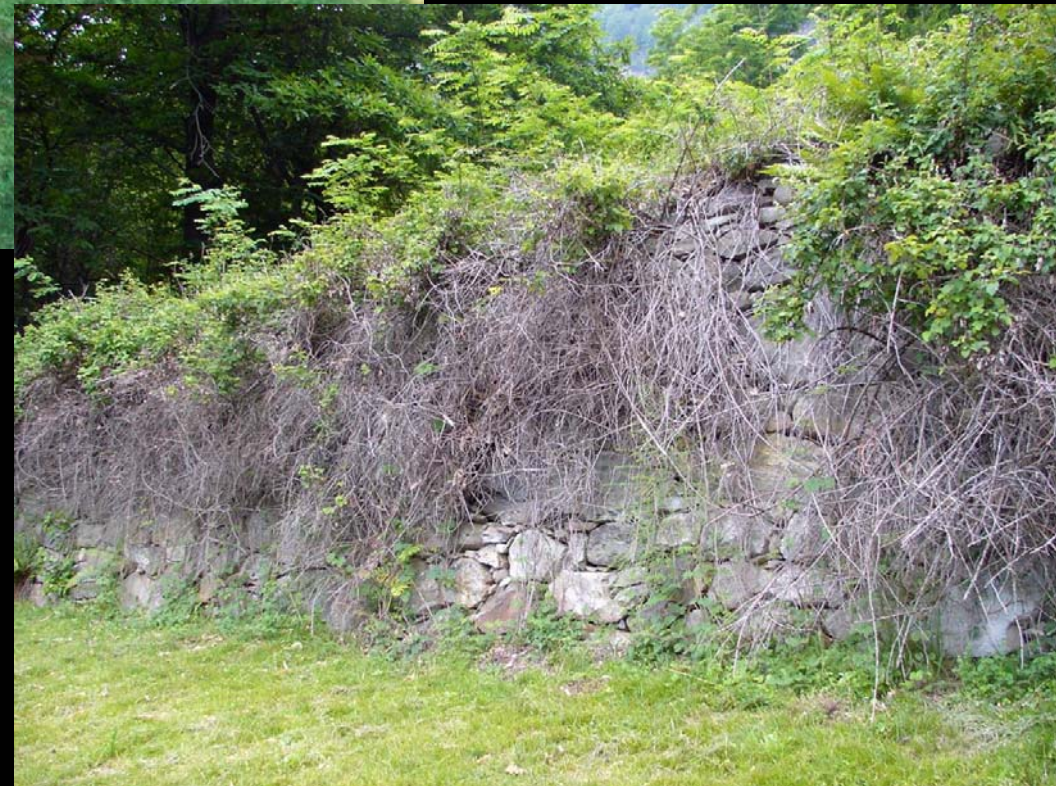
*Abandonment:  
lack of maintenance, growing of  
self-vegetation along the walls*

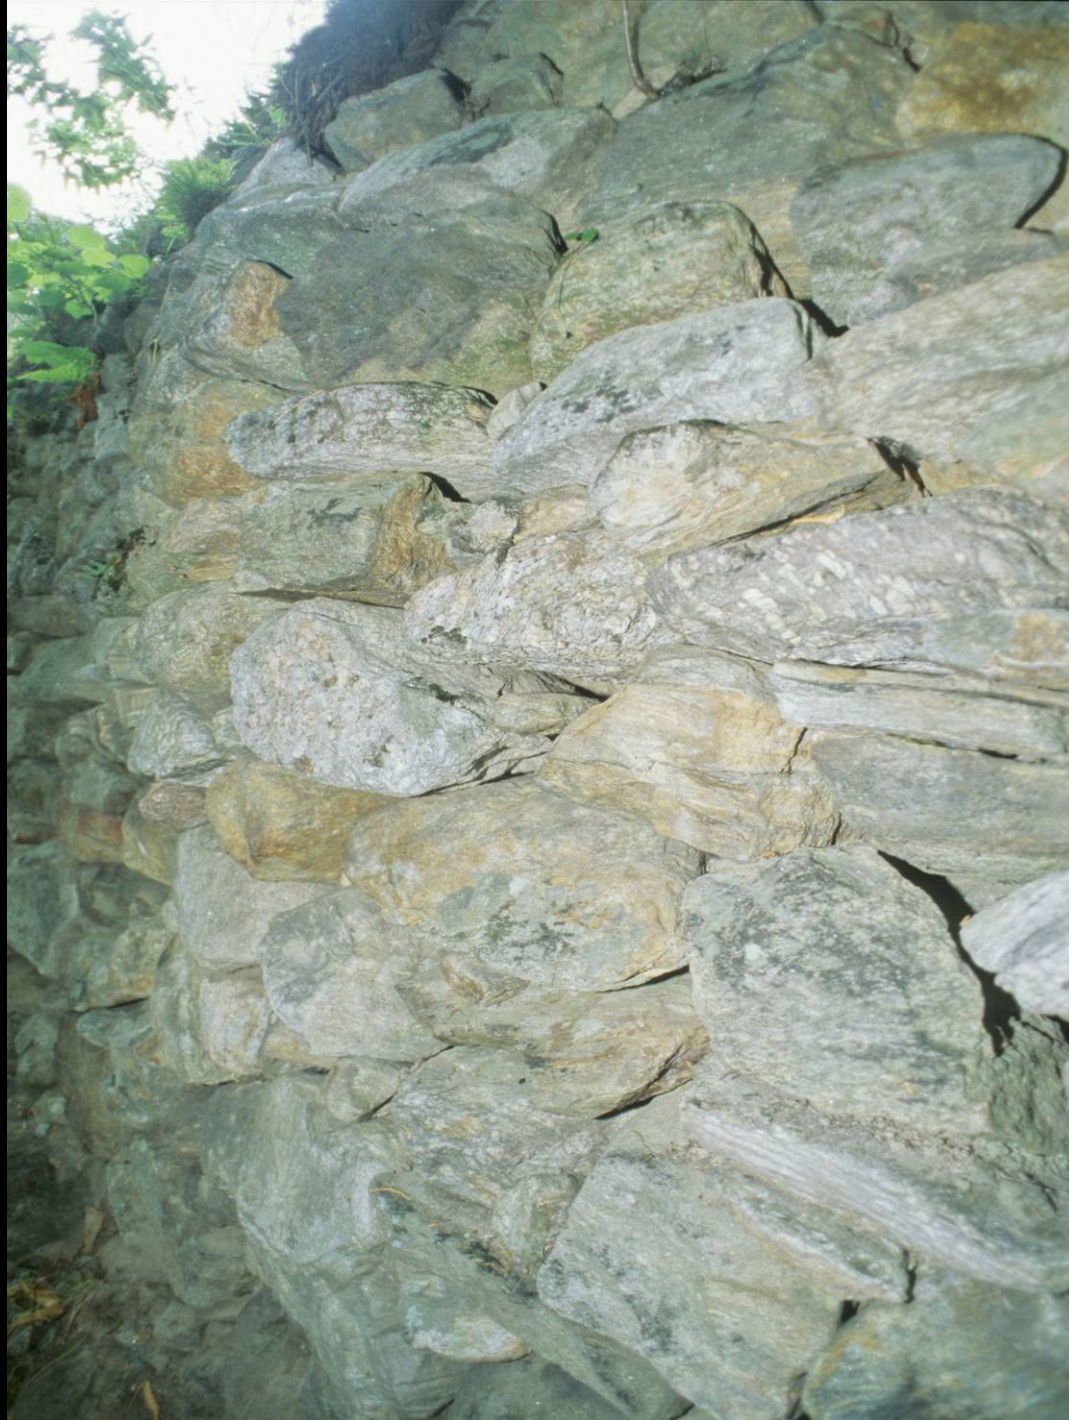
*Hydrostatic pressure and growing of self-vegetation in the internal upper part of the wall*

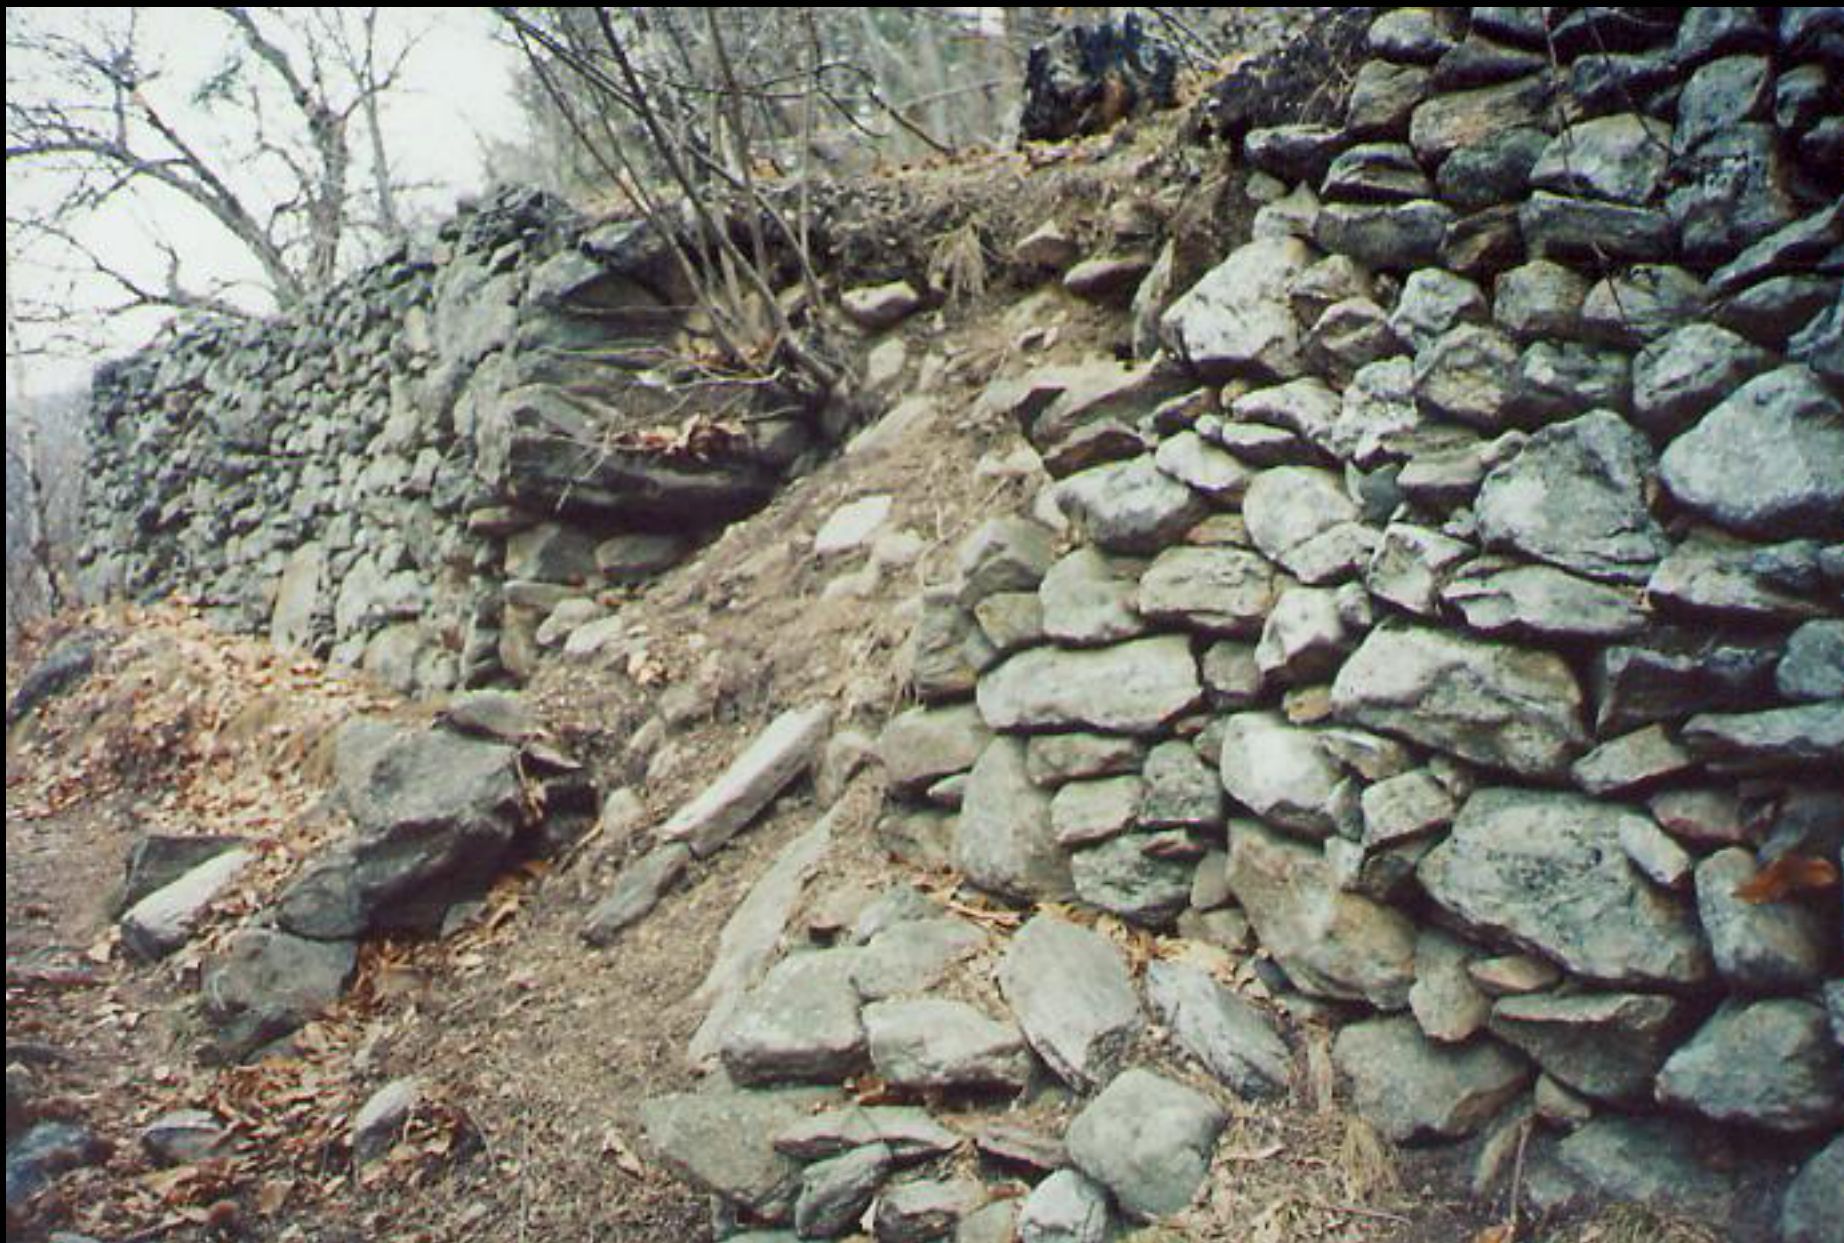
*Collapse of the overlooking terracings and mediocre building quality*

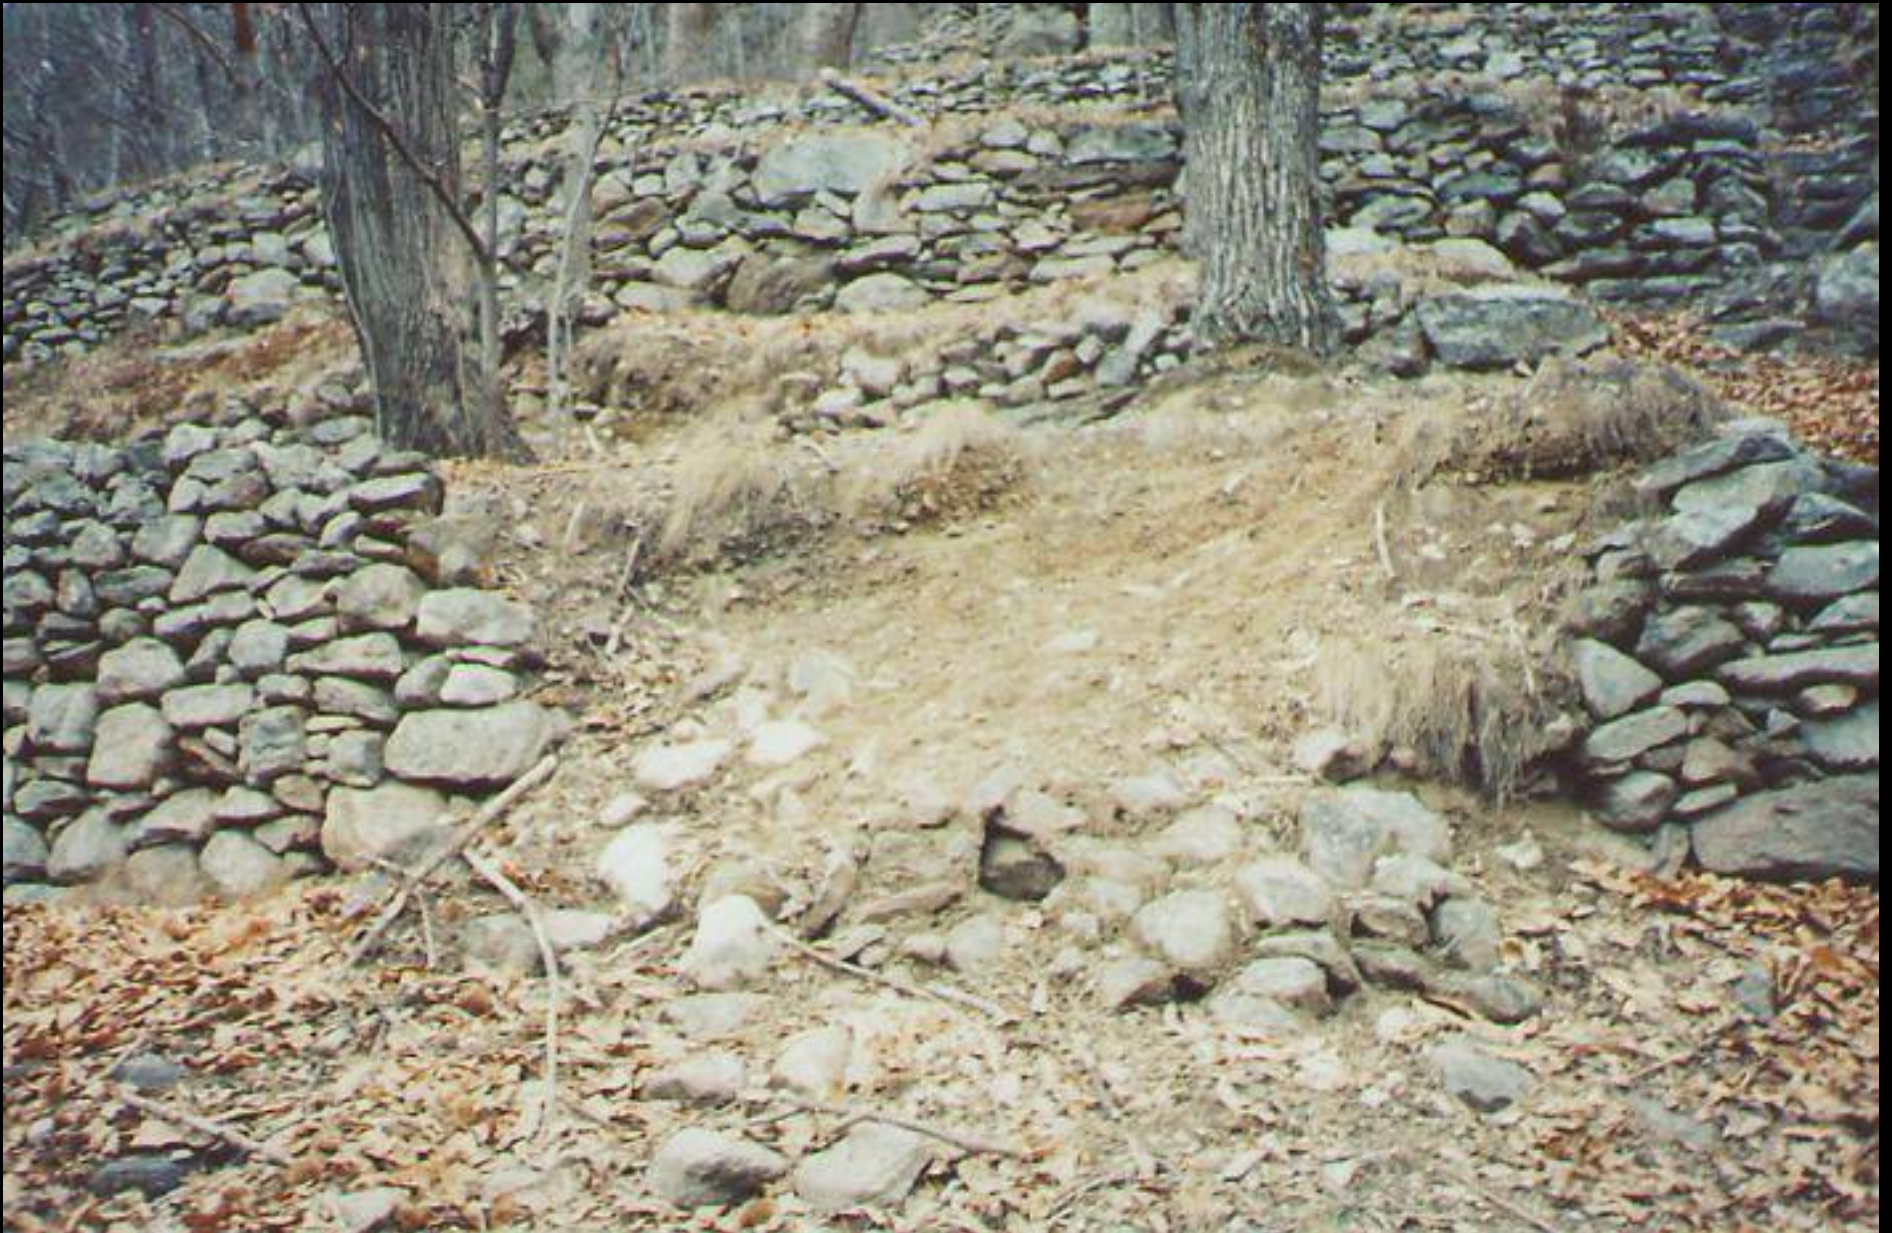
*Superficial flowing of water*

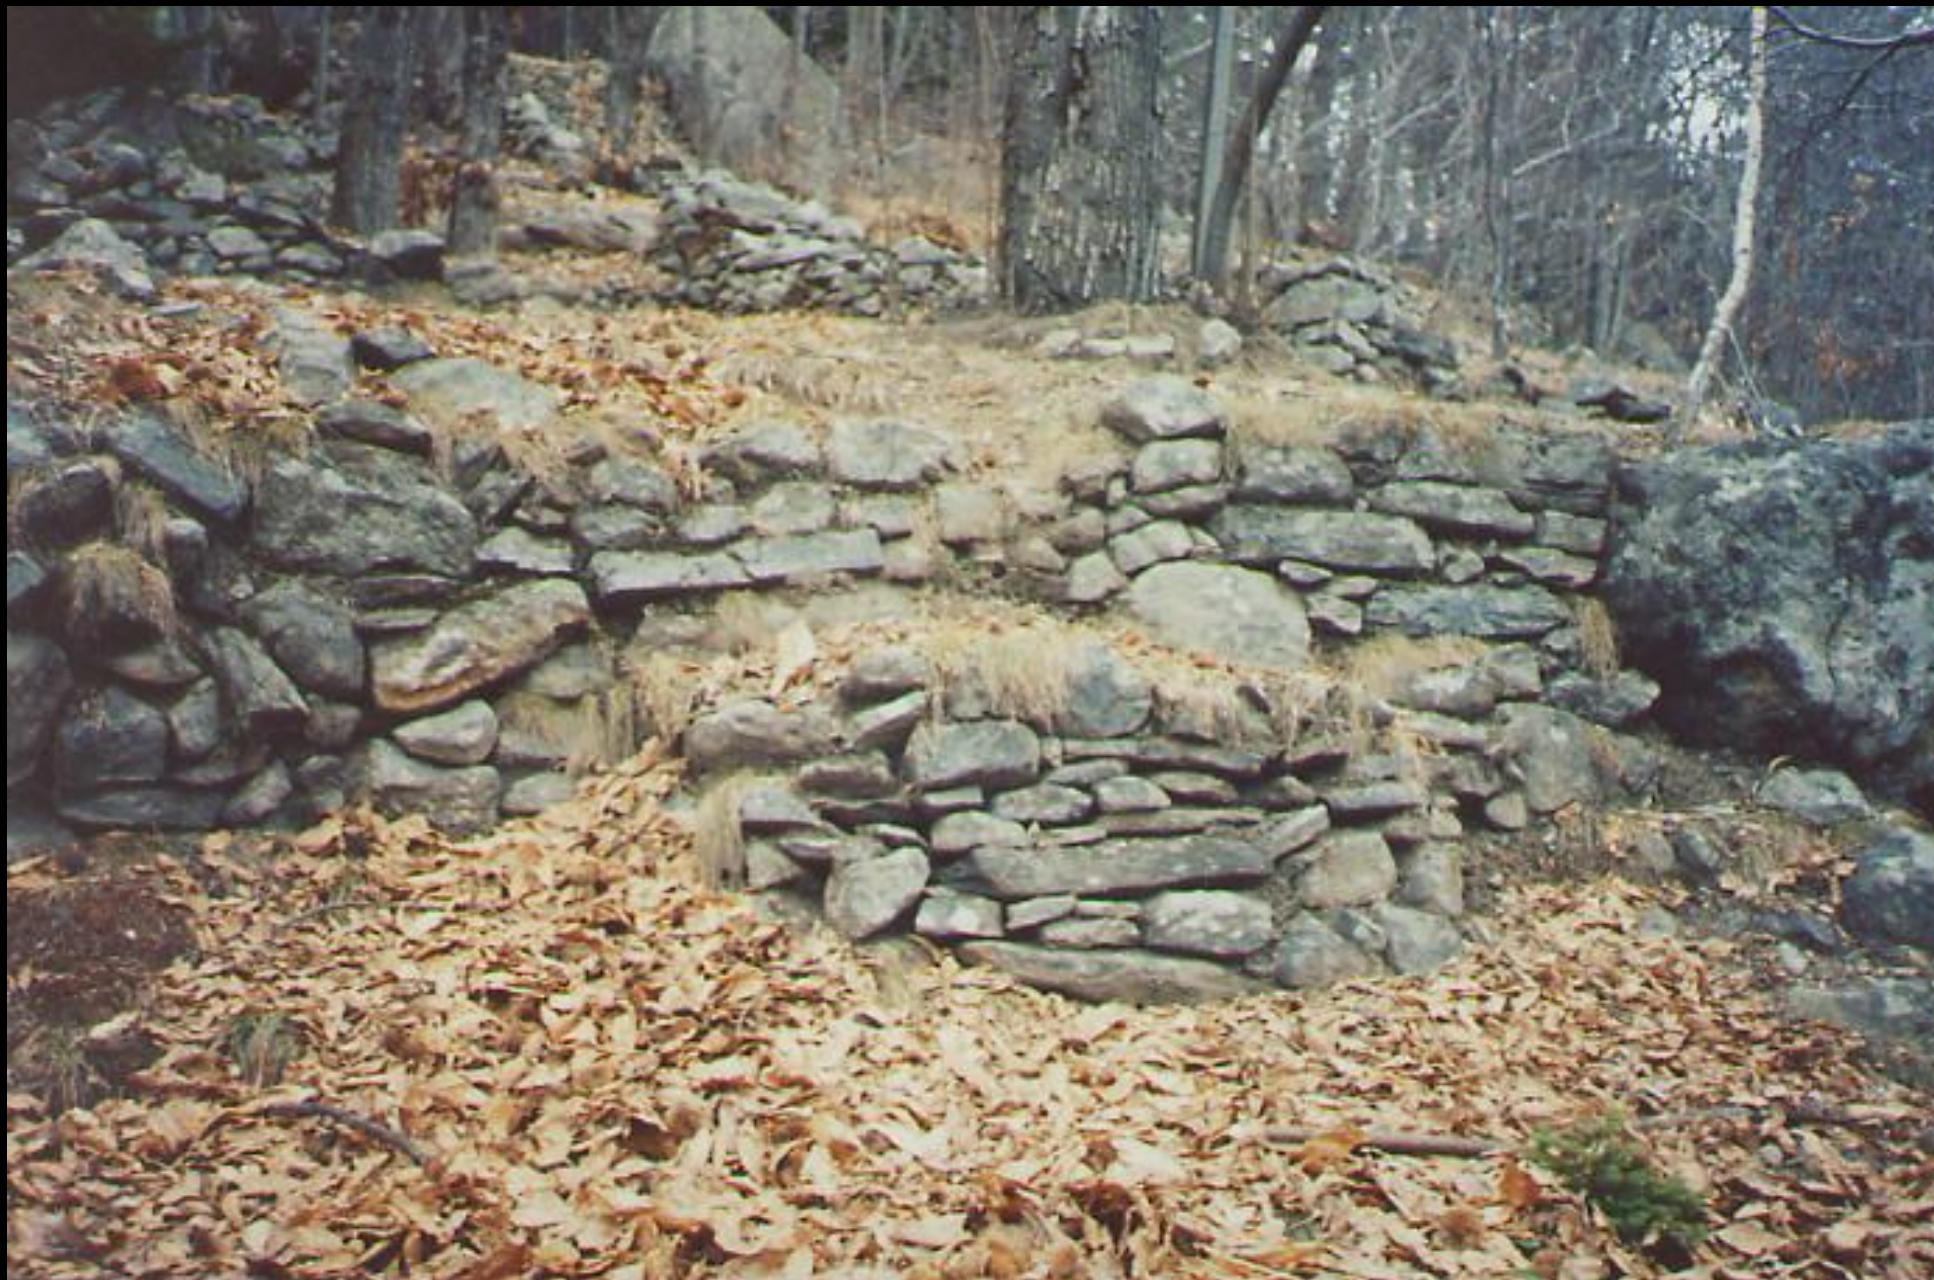
*Collapse of trees grafted in the wall*

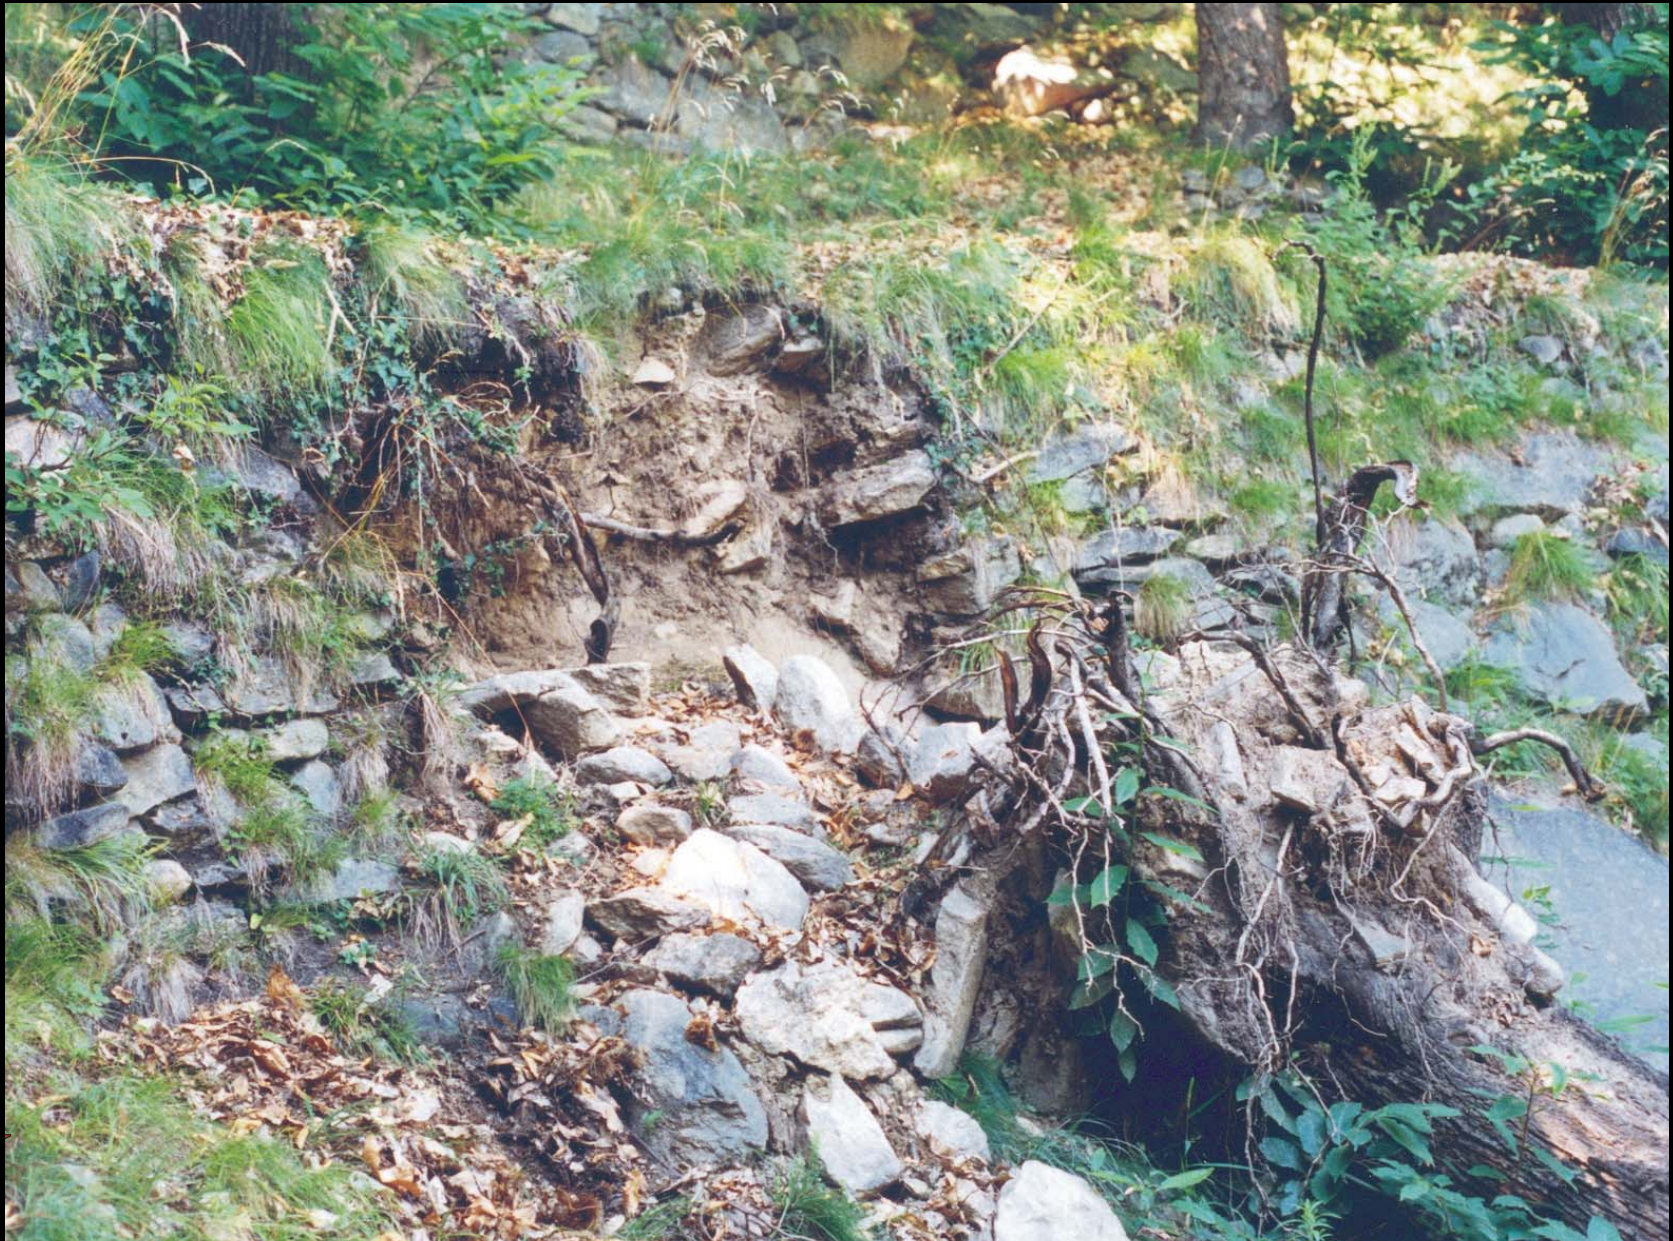
*Collapse caused by the chopping down of trees*

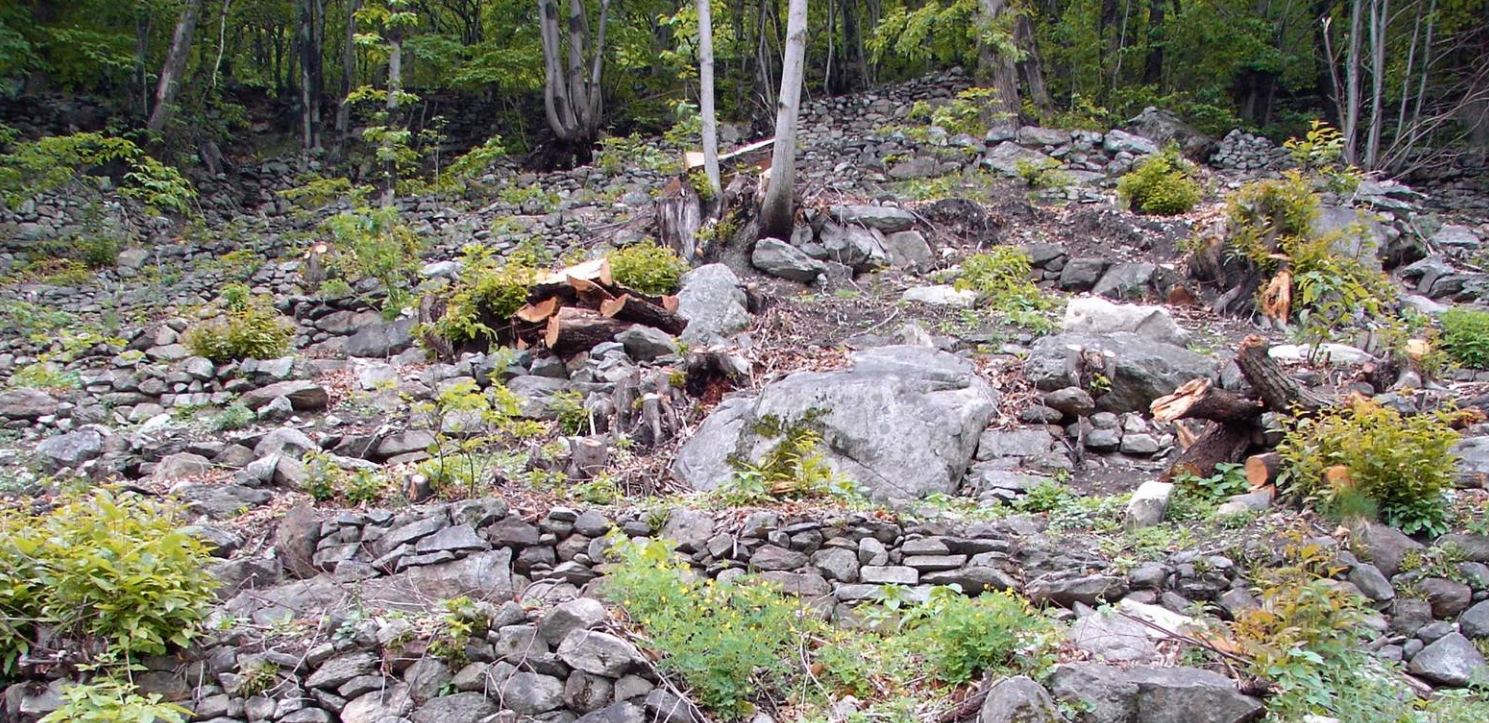
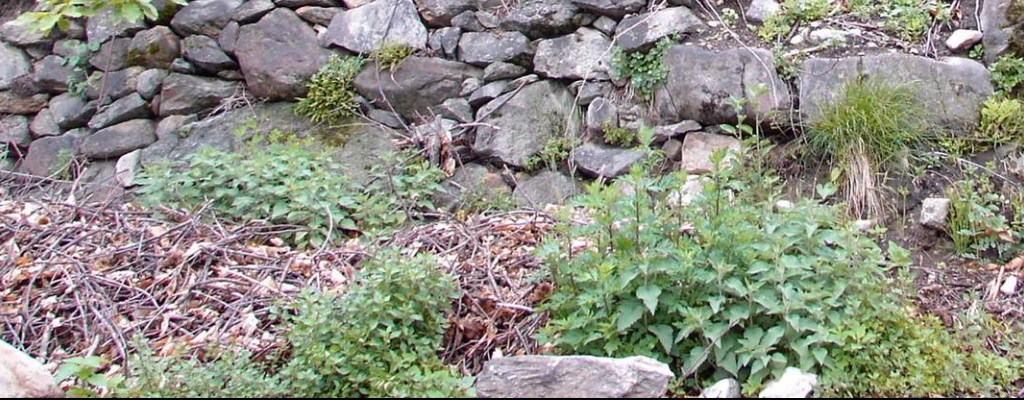
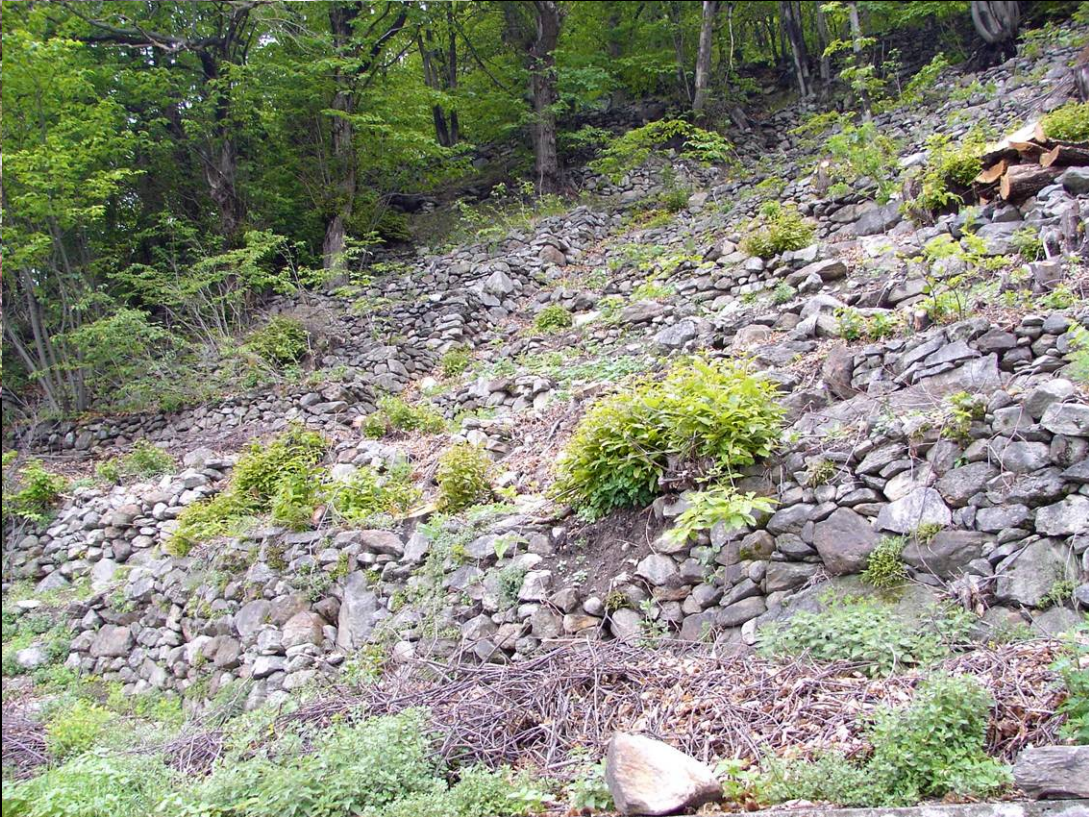
*Use of unsuitable techniques of terracing*

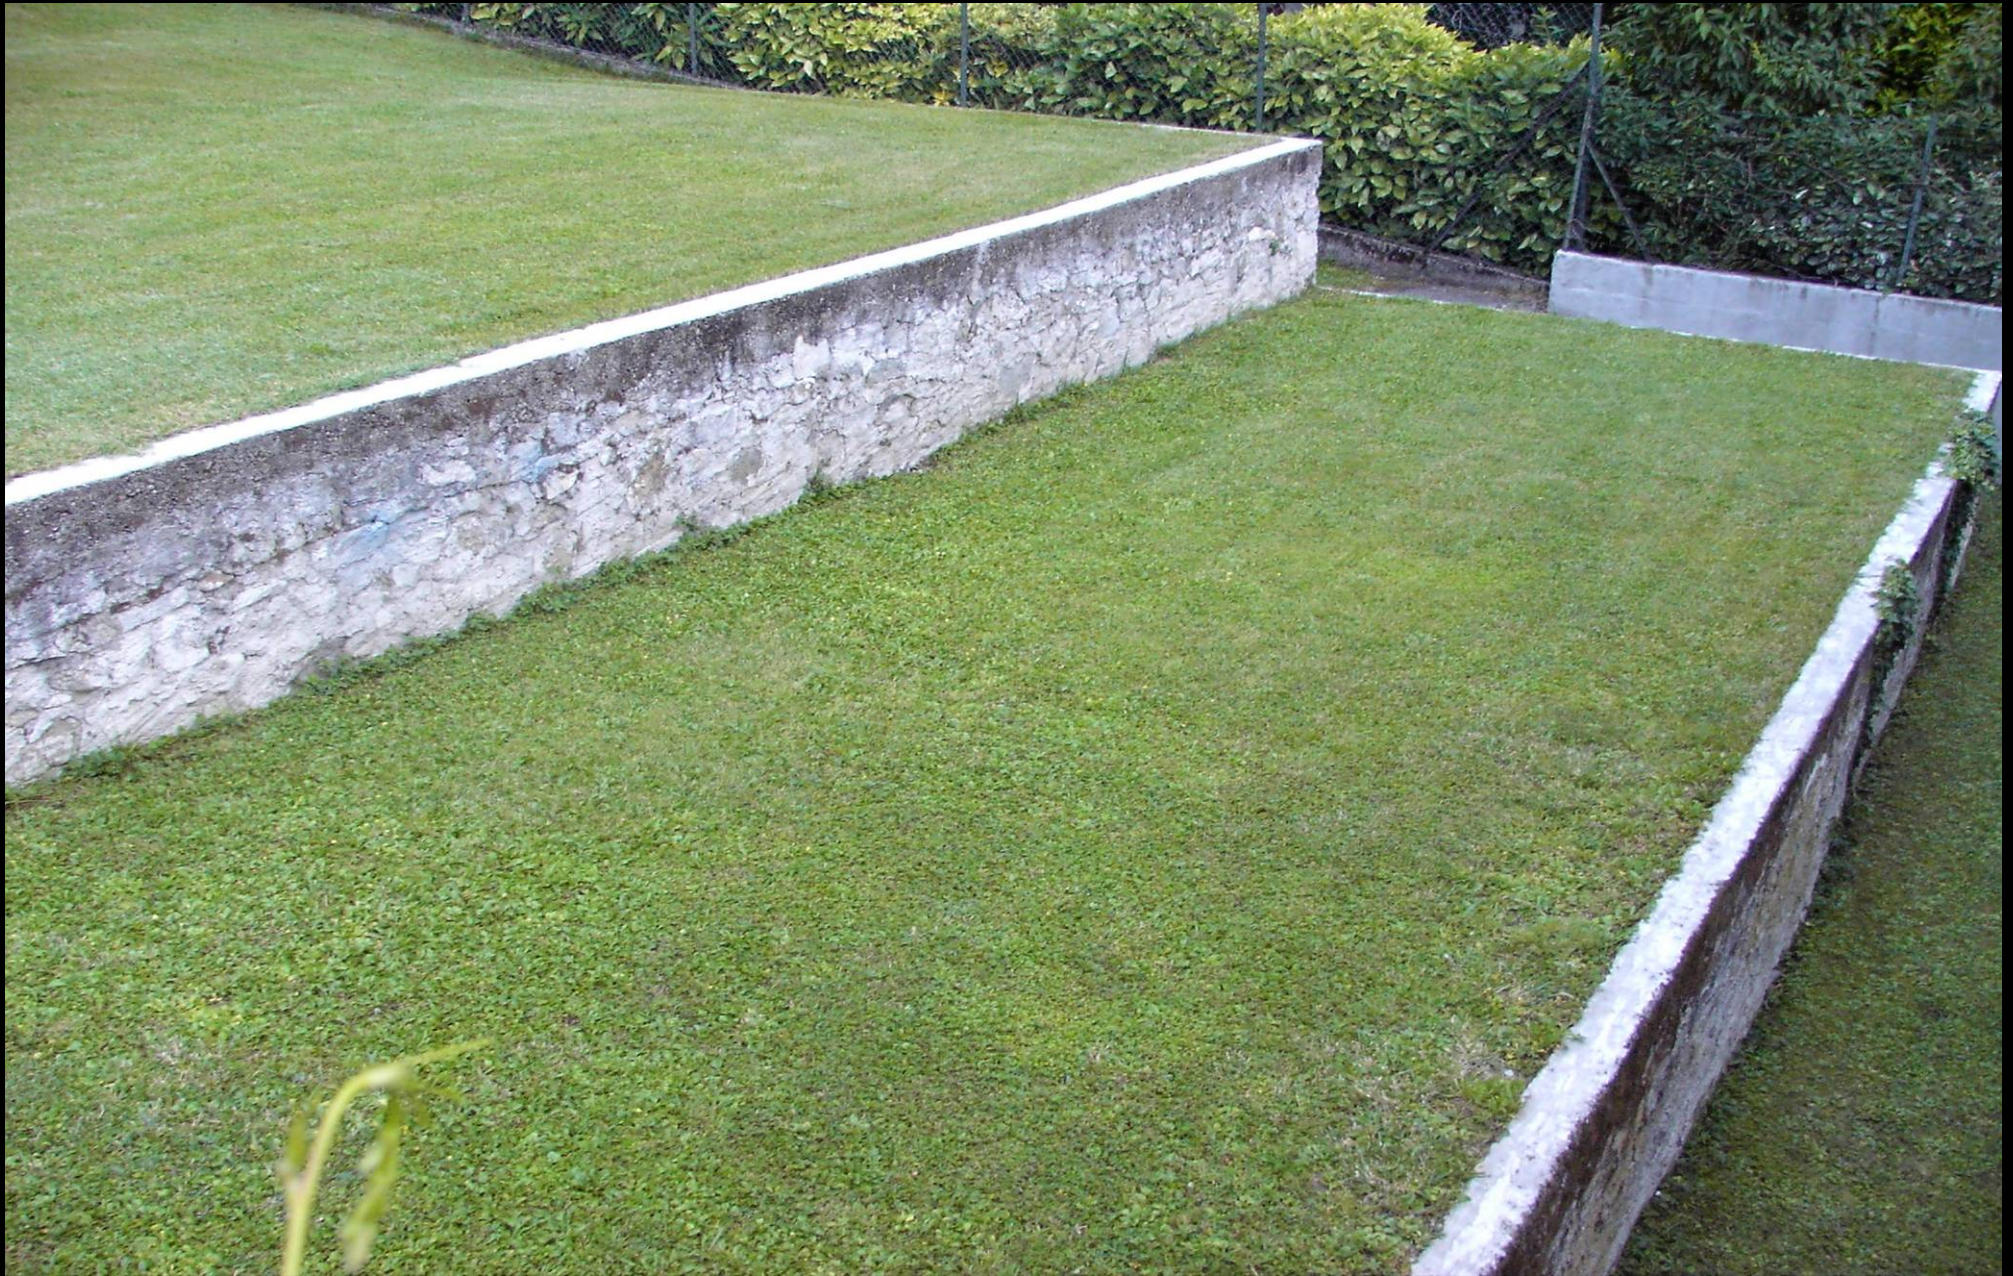
*Possible macro-  
consequences*
