Istituto di Geografia Umana – Stazione Valchiavenna

*Deterioration processes and definition  
of different risk typologies*

Alpter Project - EU Programme Interreg IIIB Alpine Space  
*Terraced landscapes of the alpine arc*

Second Transnational Workshop  
3-4 November 2005, Sondrio

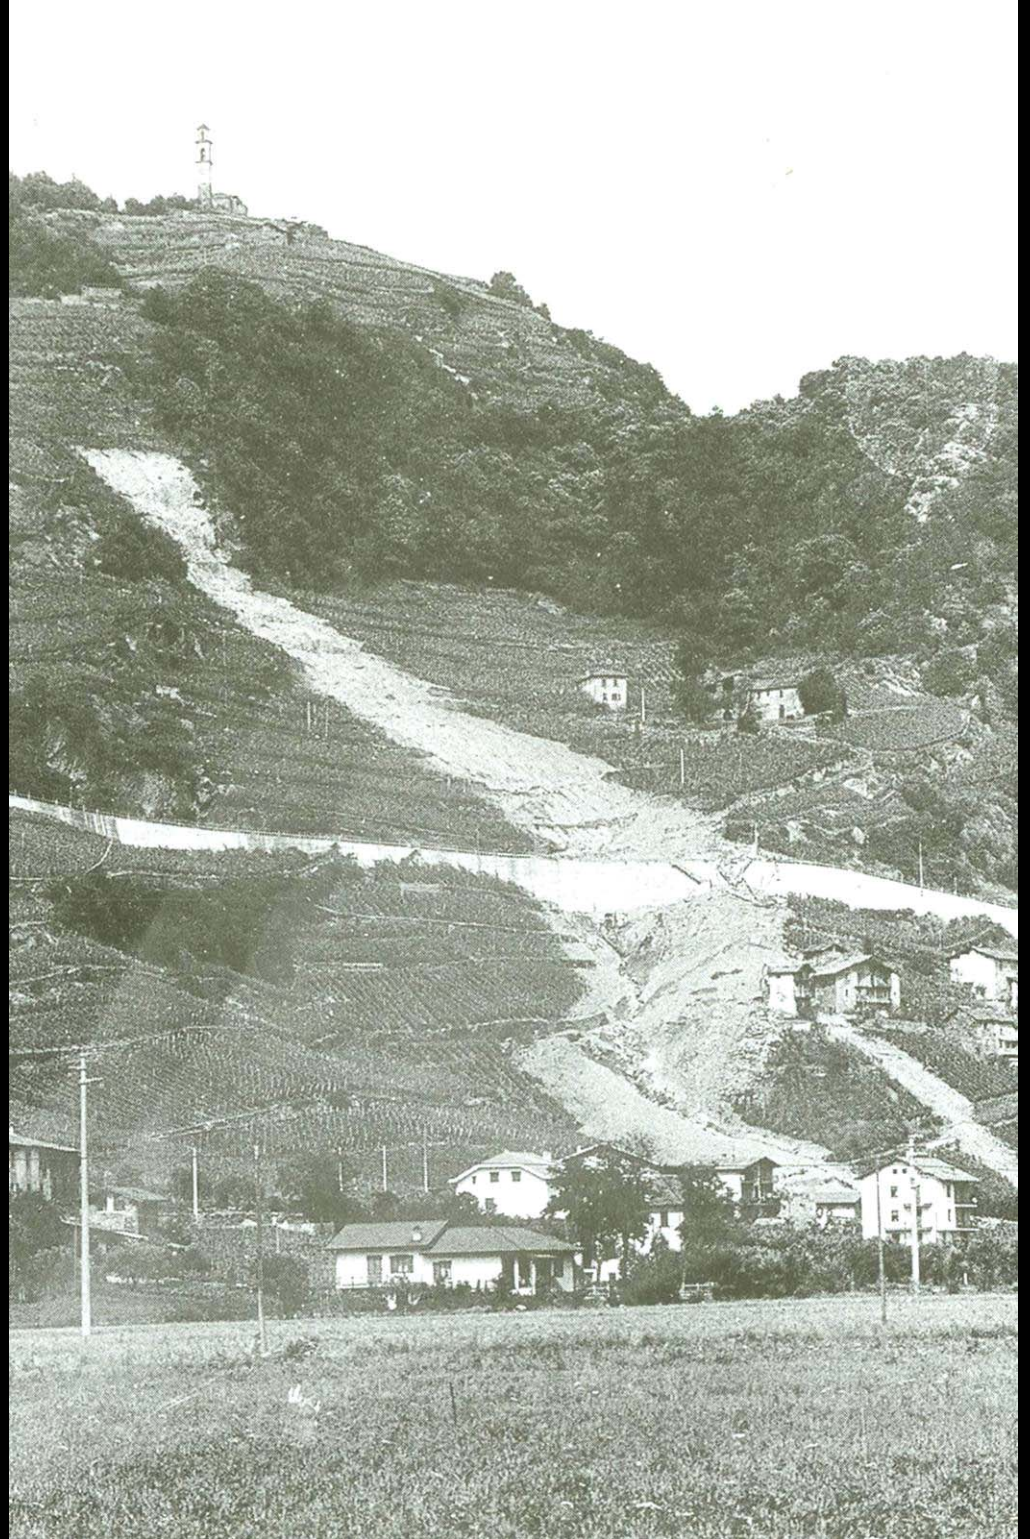
Tresenda, 1983

*Factors of temporary hazard reduction: a well structured soil in its upper horizons can slow down the regressive erosion...*

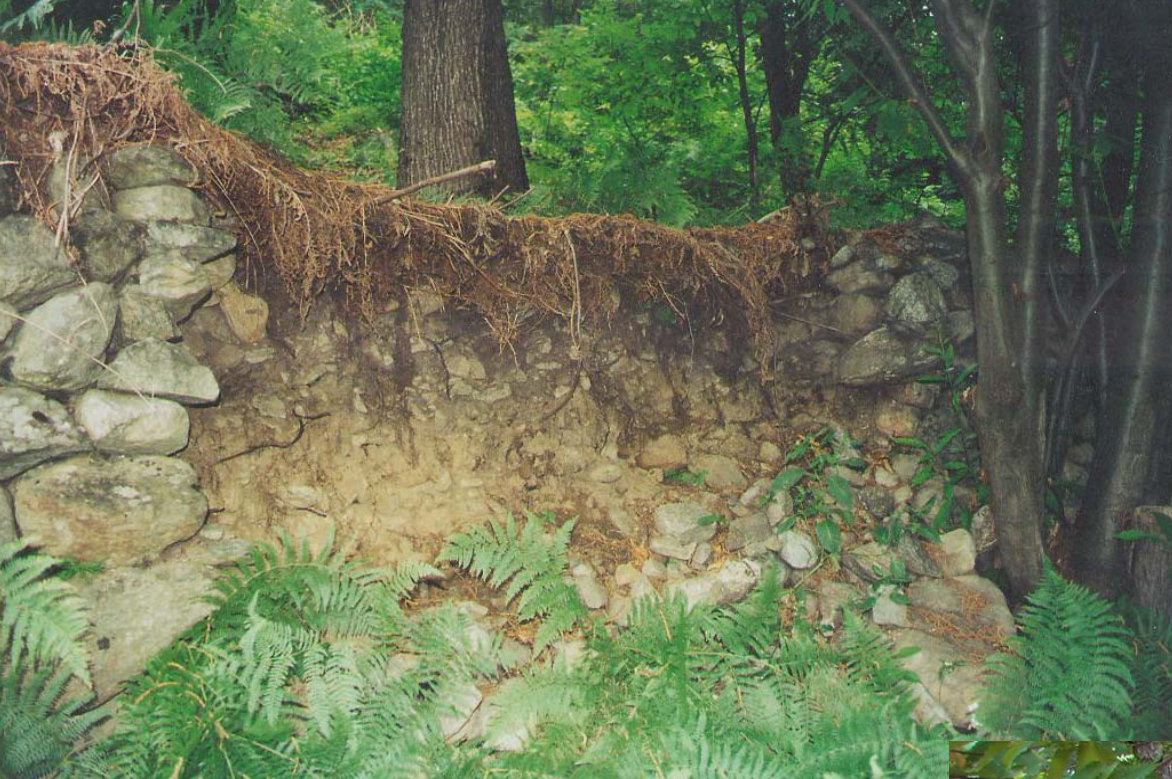
*June 2004*

*... but it does not stop it*

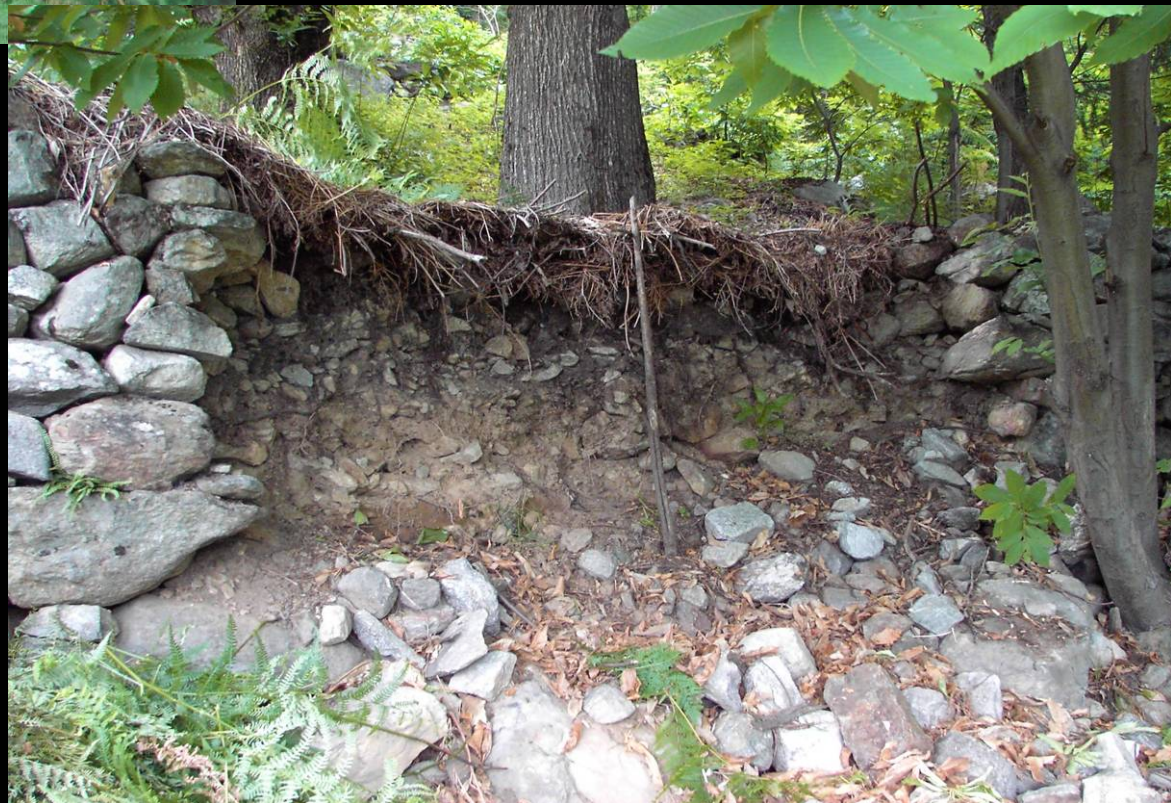
*June 2005*

*Factors of permanent hazard reduction: collapse on significantly wide terracings*

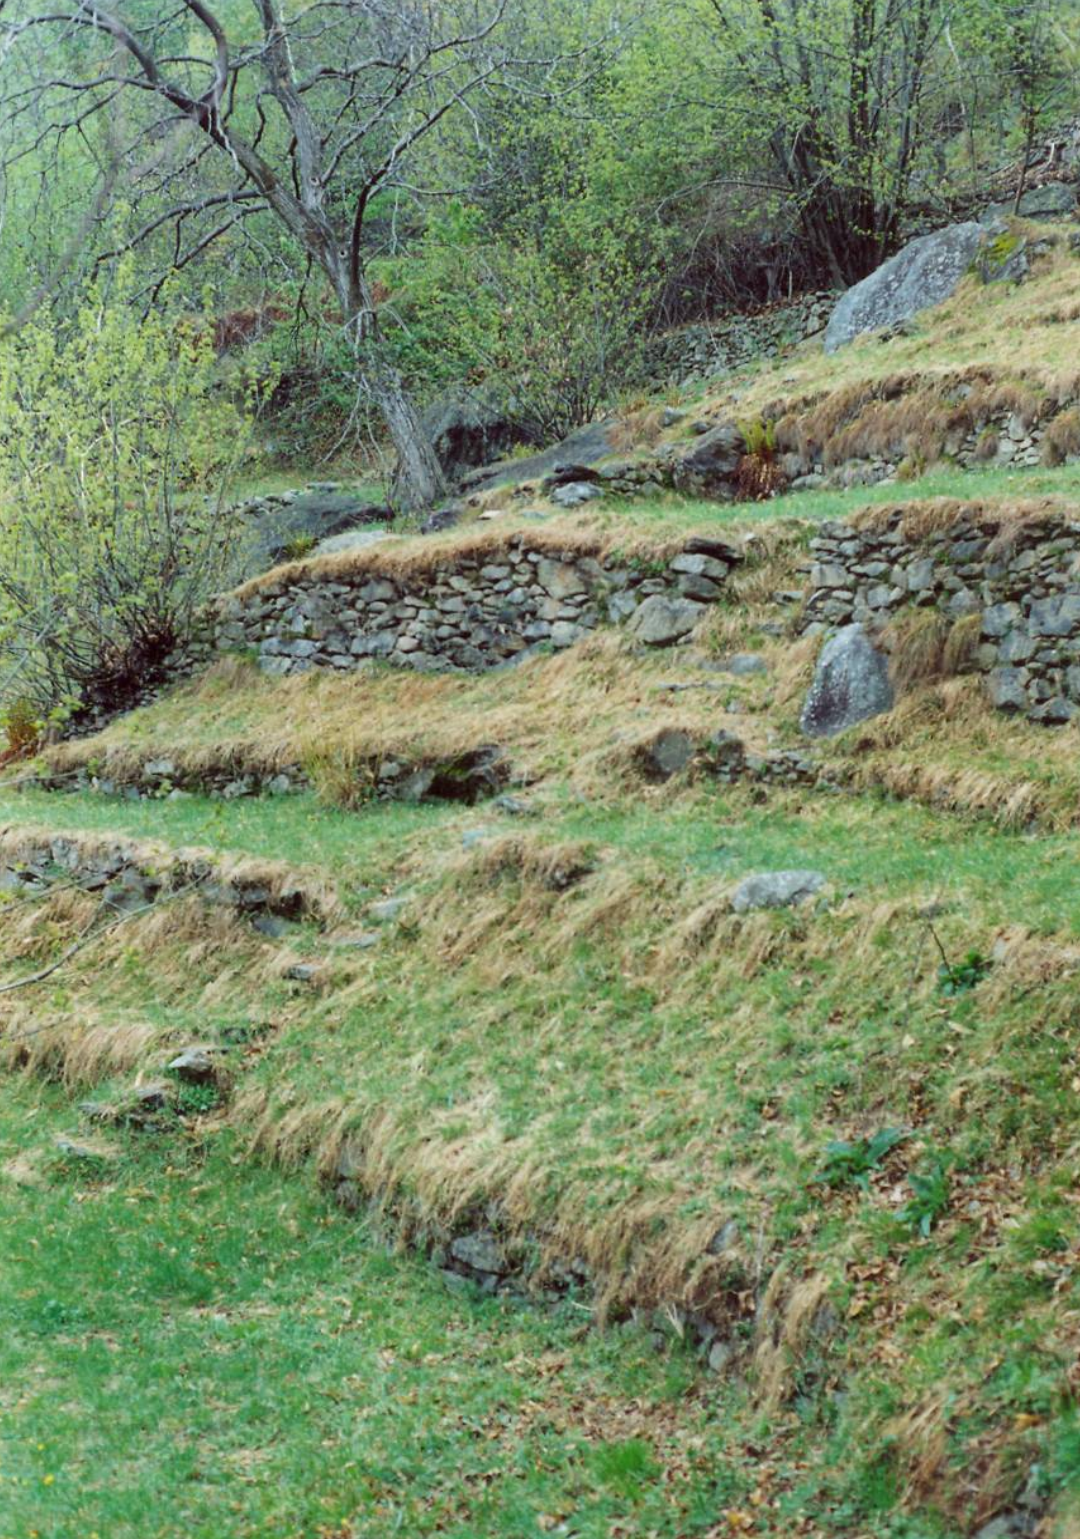
*Fossilization of portions of the slope: limited height of walls with accumulation of colluvium on the foot*

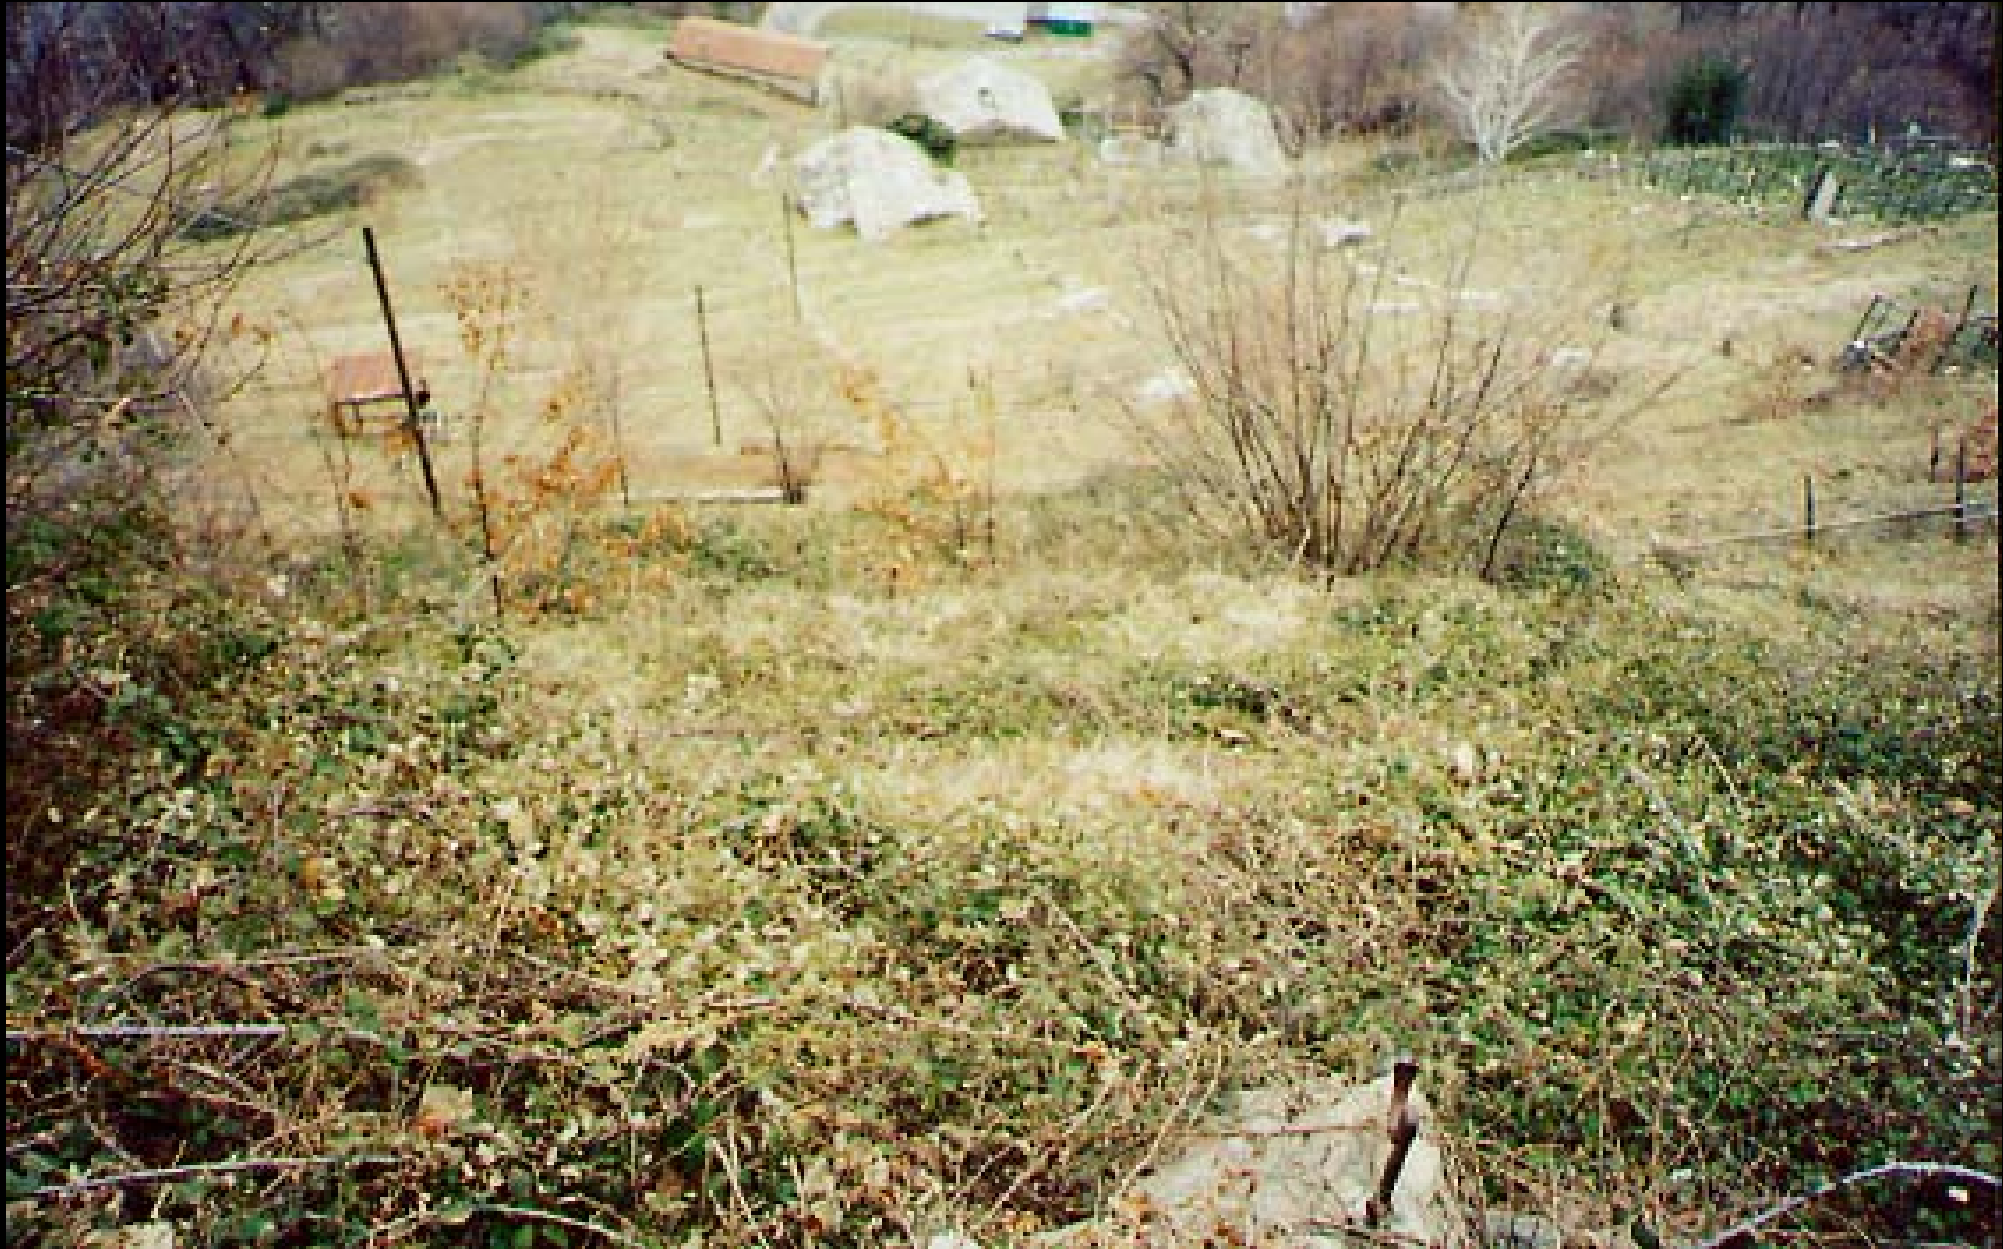
*Herbaceous and shrubby ri-naturalization: high risk of fire*
