Terraced vineyard in Alpine environment (Vallée d'Aoste – NW Italy): an anthropogenic landscape

Vth International Congress of the European Society for Soil Conservation
"Changing Soils in a Changing World: the Soils of Tomorrow"
Palermo, 25-30 July 2007

Freppaz M., Agnelli A., Drusi B., Stanchi S., Galliani C., Revel Chion V., Zanini E.

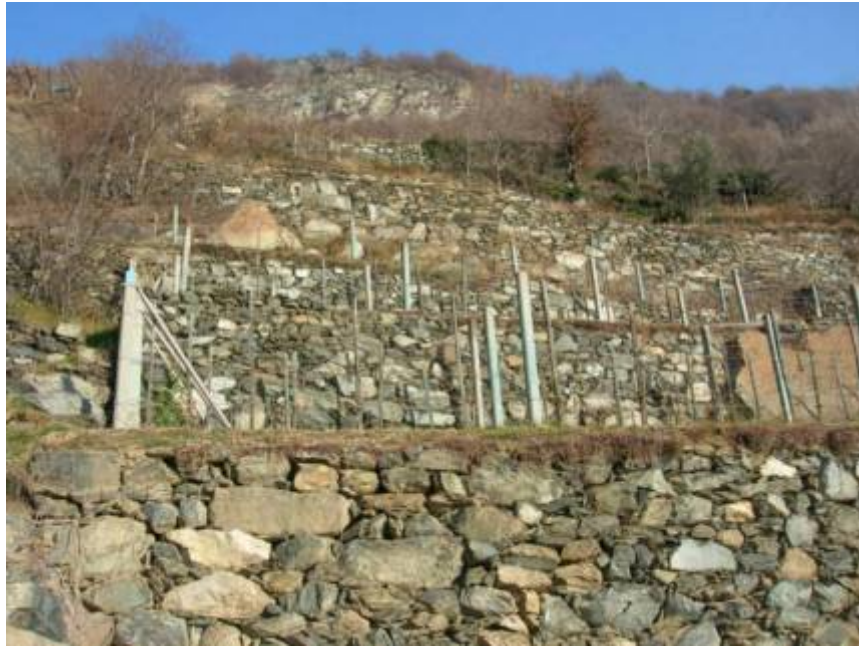
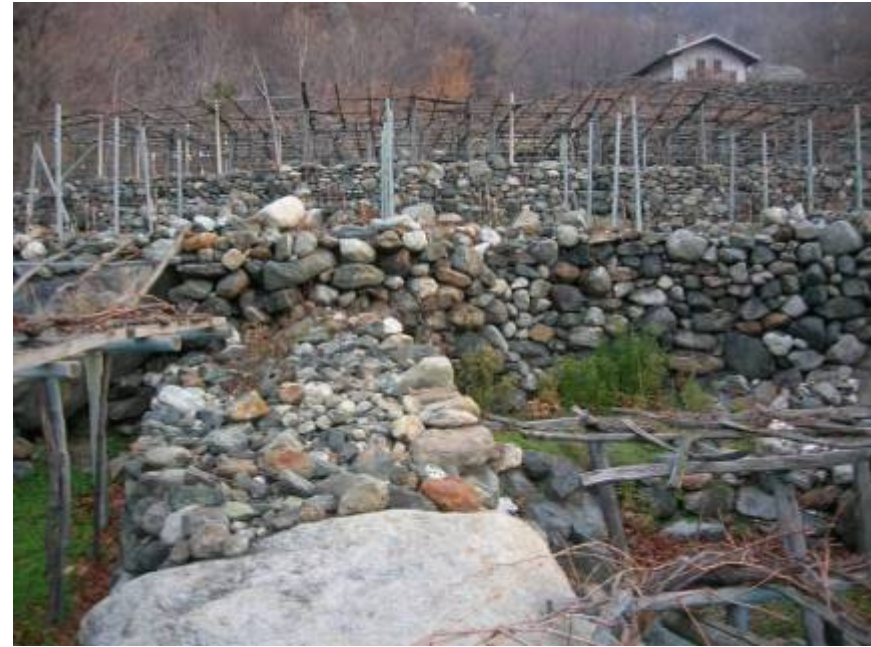
DIFFERENT TYPOLOGIES OF TERRACE WALLS

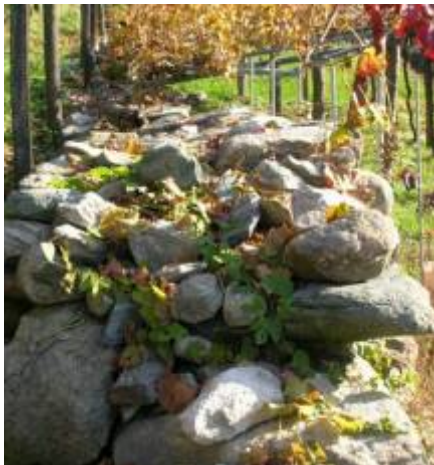
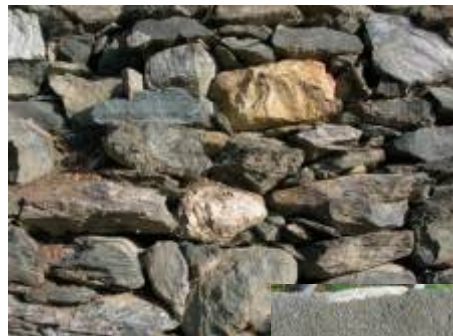
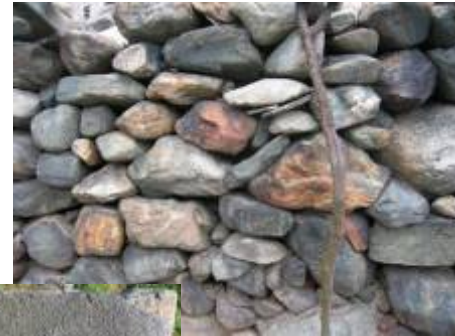
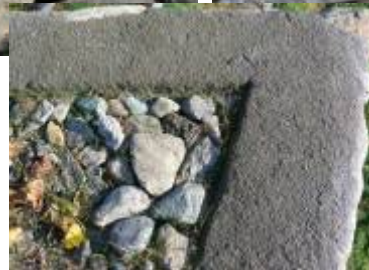
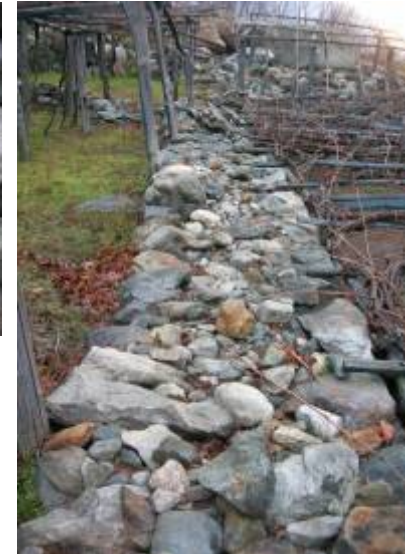
THE STUDY AREAS ARE CHARACTERIZED BY STEEP SLOPES (UP TO 100%) AND THE CONSTRUCTION OF TERRACES HAS REDUCED THE RISKS RELATED TO EROSION AND LANDSLIDES, PRESERVING THE SAFETY OF THE HUMAN SETTLEMENTS IN THE VALLEY.

FURTHER, TERRACES HAVE REPRESENTED NEW SURFACES AVAILABLE FOR AGRICULTURE.

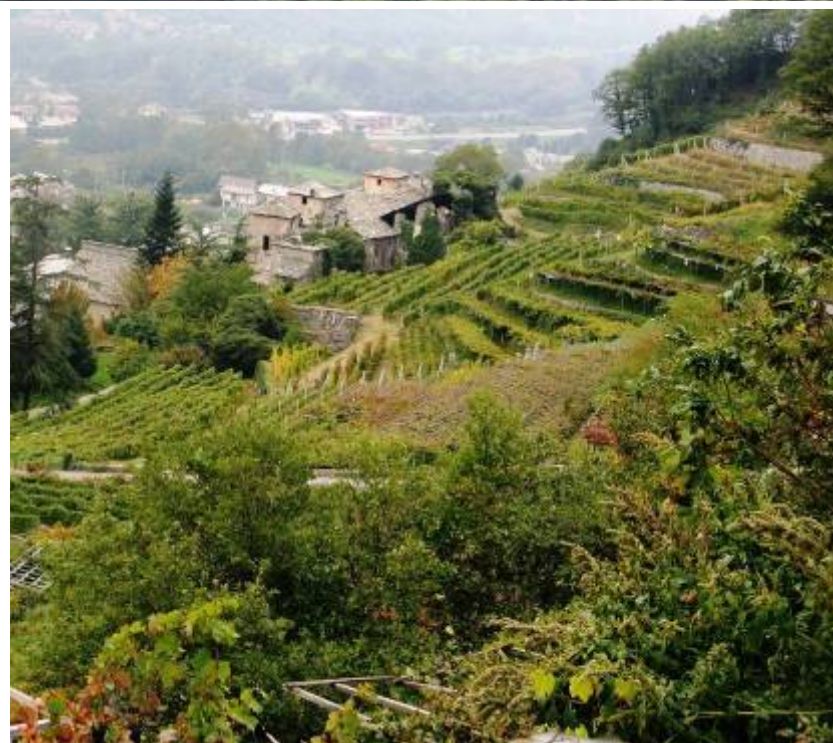
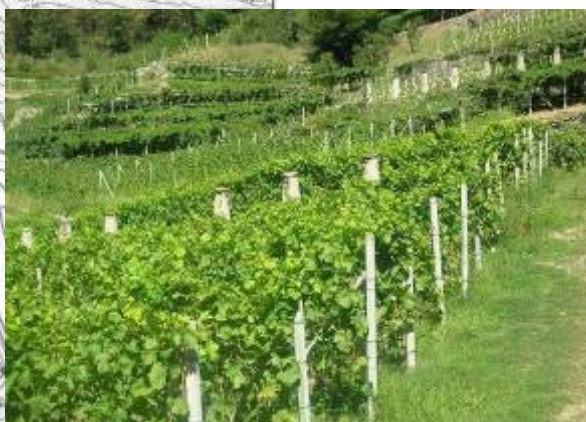
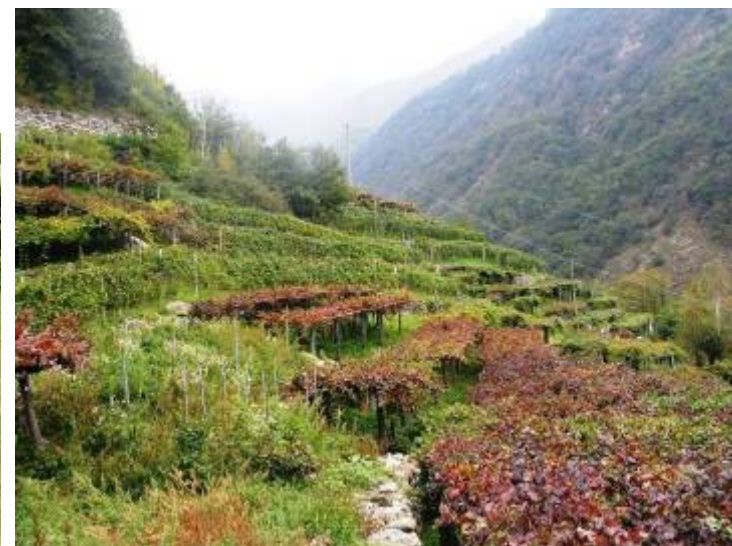
ARNAD STUDY AREA

- **GEOMORPHOLOGY CONNOTED BY QUATERNARY MORENIC DEPOSITS**
- **VINEYARD TERRACES STILL CULTIVATED AND GENERALLY IN GOOD CONSERVATIVE CONDITIONS**
- **ESPALIER-SHAPED AND PERGOLA VINEYARD LANDSCAPES**

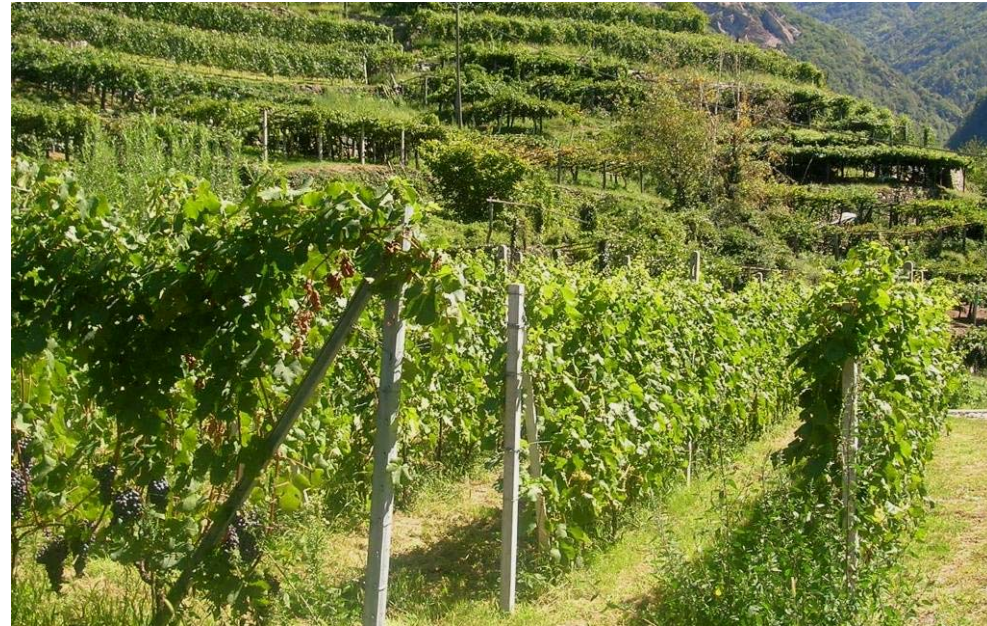
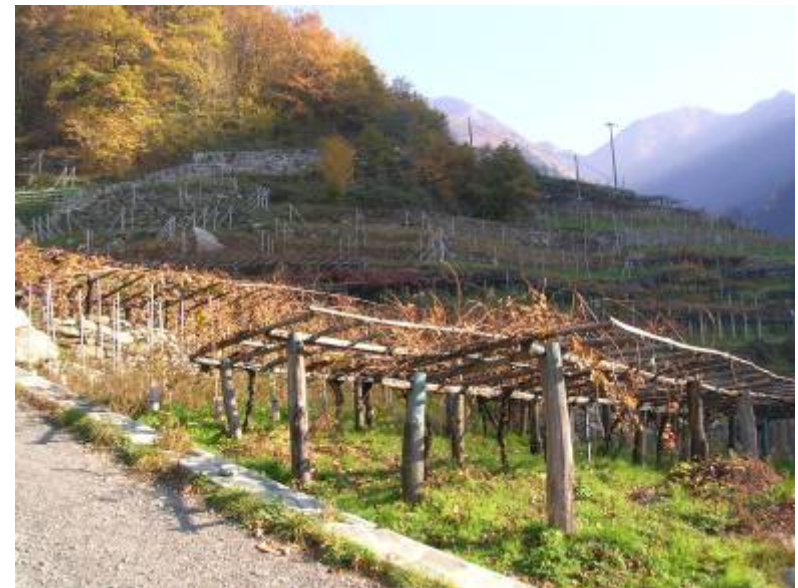
ARNAD STUDY AREA

- WOOD OR CONCRETE PILE SUPPORTING STRUCTURES
- DRY-STONE AND CLEFT-STONE TERRACE WALLS
- LANDSCAPE QUALITY NOT YET COMPROMISED BY DISFIGURING ELEMENTS

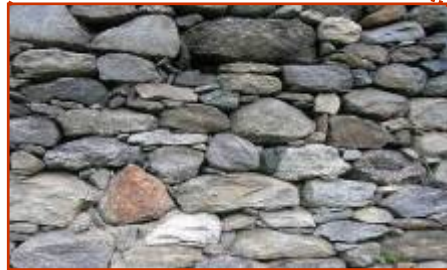
DRY-STONE MASONRY

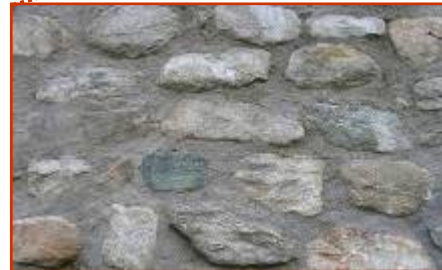
GROUTED MASONRY

"opus incertum" stone frame (a well known building technology since the Roman age)

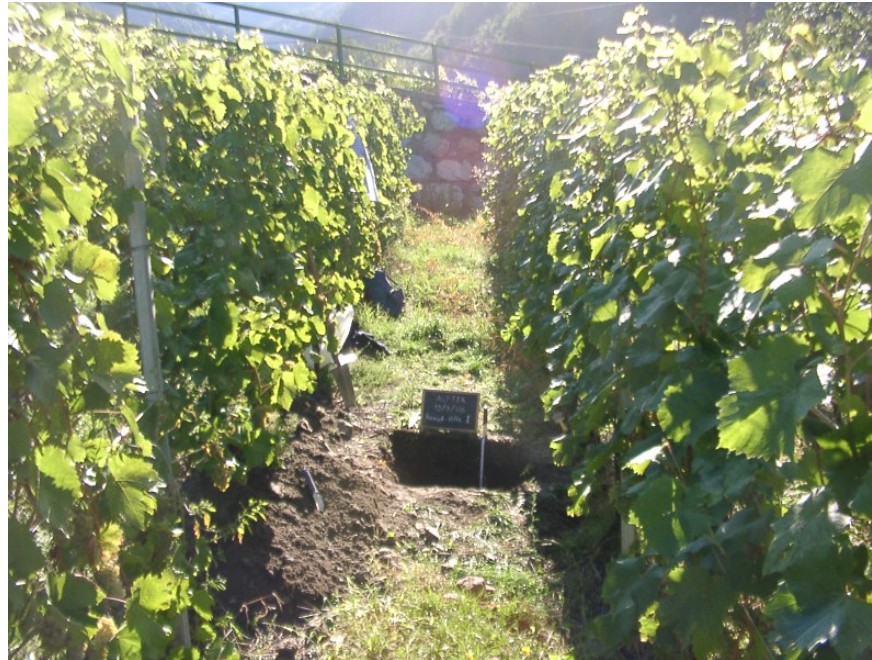
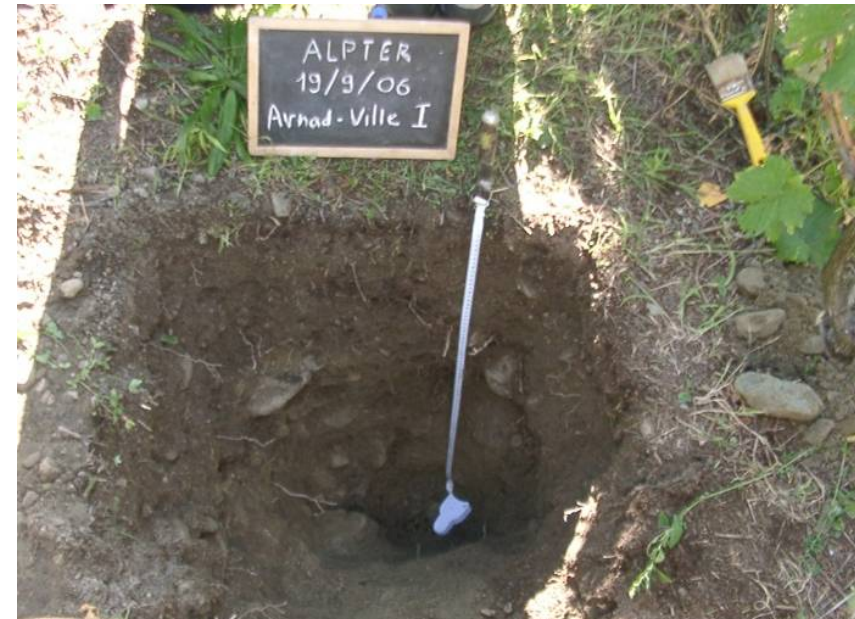
ESPALIER-SHAPED

ARNAD I 13 years old vineyards

Technic **Escalic** Cambisol

SOIL DESCRIPTION

Oi: 2.5-2 cm

A: 0-2.5 cm

EB: 2.5-3.5 cm.

Shallow and discontinuous, with patches of 20-25 cm of diameter mostly located near the trunks of the vines (around 25 cm). The upper part of this horizon, rich of pruning residues, is colonized by fungal mycelium.

Bw1: 3.5-27.5 cm

Skeleton 40%, dimension of the clasts: 1-3 cm.

Site	Horizons	Depth	Skeleton	pH	Available P	C tot	N tot
ARNAD I		cm	% by weight		mg kg ⁻¹	g kg ⁻¹	g kg ⁻¹
	Ap	0-3	9.4	5.8	24	123.3	7.7
	EB	3-4	19.4	6.5	44	51.3	2.8
	Bw1	4-27	49.3	7.0	27	19.8	1.6
	Bw2	27-37	53.4	7.5	17	12.8	0.9
	BC1	37-60	53.7	7.9	16	7.2	0.5
	BC2	60-79	30.8	8.2	9	5.5	0.1
	BC3	79-91+	72.3	8.3	11	4.3	0.1

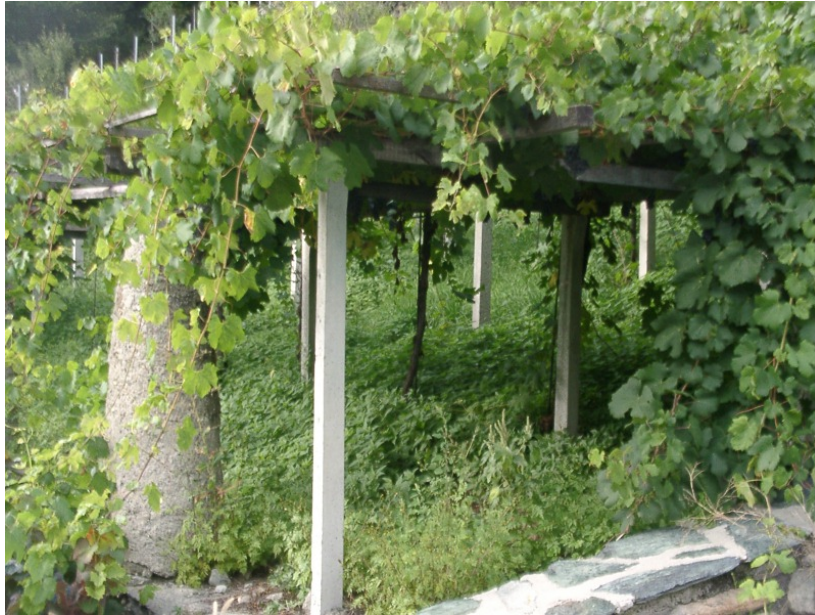
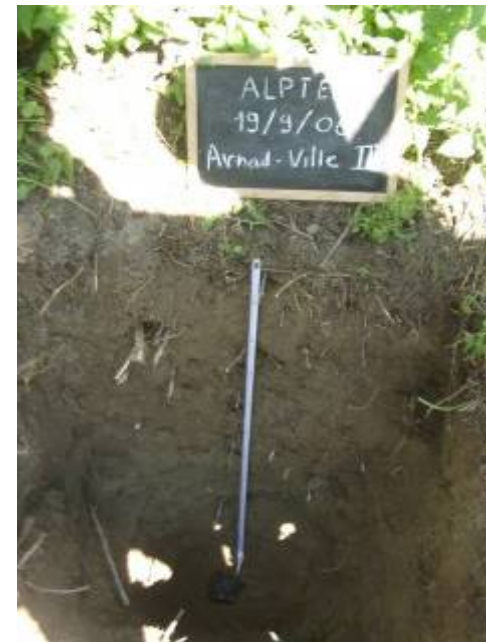
PERGOLA-SHAPED

ARNAD II

12 years old vineyards

Technic Escalic Cambisol

Site	Horizons	Depth	Skeleton	pH	Available P	C tot	N tot
ARNAD II		cm	% by weight		mg kg ⁻¹	g kg ⁻¹	g kg ⁻¹
	Ap	0-2	21.4	7.1	25	20.1	1.5
	Bw1	2-17	23.6	7.2	26	9.4	0.7
	Bw2	17-33	23.6	7.4	23	10.5	0.9
	Bw3	33-51	15.3	7.8	15	8.0	0.8
	Bw4	51-81	6.3	8.3	14	6.6	0.6
	Bw5	81-100	8.3	8.4	13	4.8	1.1
	BC	100-110+	20.3	8.1	7	5.0	2.1

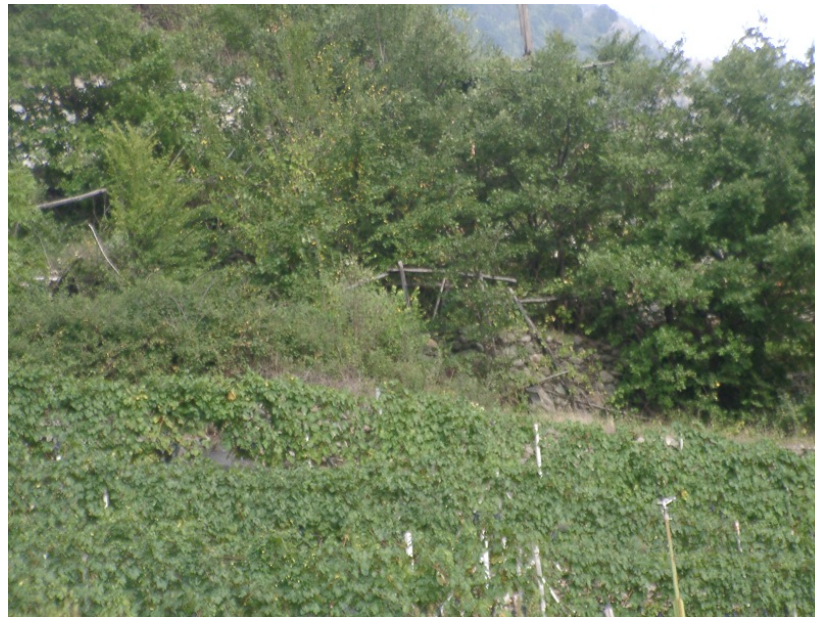
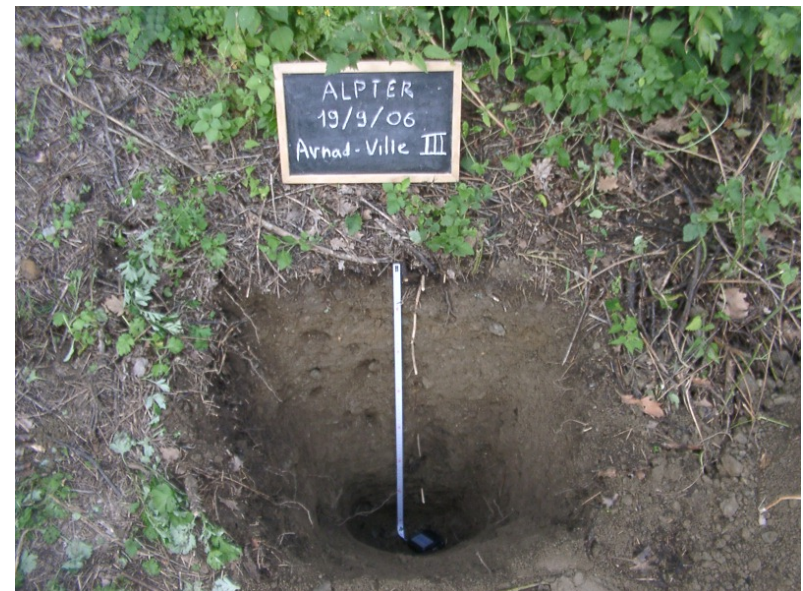
ARNAD III Abandoned 30-35 years

Technic Escalic Cambisol

Site	Horizons	Depth	Skeleton	pH	Available P	C tot	N tot
ARNAD III		cm	% by weight		mg kg ⁻¹	g kg ⁻¹	g kg ⁻¹
	A	0-2	13.6	7.3	40	42.8	4.1
	AB	2-9	14.9	7.2	37	15.4	3.2
	Bw1	9-17	34.9	6.4	7	14.5	2.2
	Bw2	17-28	30.9	6.6	0	9.0	1.1
	Bw3	28-42	22.4	7.2	7	19.0	0.8
	Bw4	42-57	18.7	7.5	2	20.4	1.3
	BC	57-68+	47.4	7.8	3	19.9	0.6
